2006  
VOL.7 NO.11

# 싱글레이션에 의해 발생하는 커패시터 균열의 음파 영상

## Acoustic Imaging Of Capacitor Cracks Caused By Singulation

*By Tom Adams, consultant, Sonoscan, Inc.*

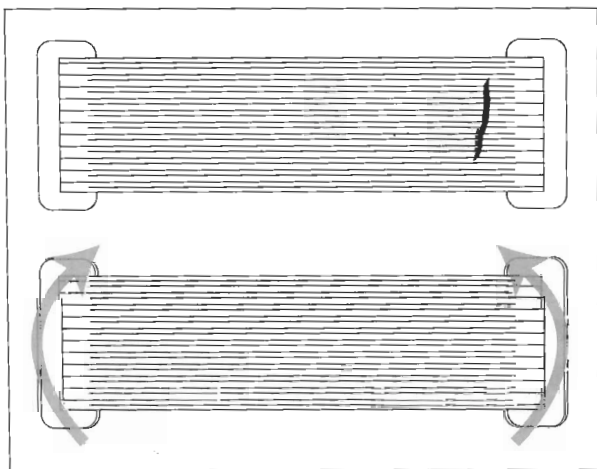
그림 1. 싱글레이션 동안 FR4 기판의 유연성은 표면실장된 세라믹 칩 커패시터 위에서 기계적 응력(화살표)을 받는다. 만일 그 응력이 커지면 커패시터에 수직의 균열이 생기게 되는 것이다(위 그림).

Sonoscan 응용 연구소의 연구원들은 오랜 경험을 통해 PCB가 어셈블리의 끝에 싱글레이션(singulation)될 때 단자 근처의 수직 균열이 자주 발생한다는 것을 알고 있었다. 기판이 싱글레이션될 때, 각 기판은 약간 휘어진다. FR4 기판은 다소 유연하다. 그러나 세라믹 칩 커패시터는 매우 단단하다. 게다가 커패시터는 기판에 강하게 솔더된다.

때때로 PCB가 휘는 것으로부터의 기계적 응력은 커패시터의 균열의 형성에 의해 일어난다(그림 1). 그런 균열은 전형적으로 수직이고 단자 근처에 있으며, 언제나 커패시터의 표면까지도 착하지는 않는다. 그래서 그것은 눈으로 볼 수 없다. Sonoscan의 연구소는 실패했던 시스템의 제조업체에게 영상과 영상의 해석 내용을 보고했다.

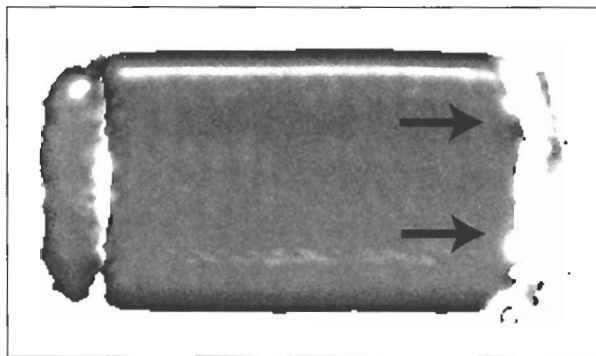
그림 2. Sonoscan 응용 연구소로부터 받은 음파 영상은 수직의 균열  
이 단자와 평행함을 보여준다. 이 전형적인 균열은 싱글레이션  
동안 기판을 파손할 수 있다. 균열은 모든 초음파를 사실상 반  
사하기 때문에 밝은 흰색이다.

마지막 단계로서, 끊어진 패널을 자기장 고장을 일으켰던 기  
판에서 떼어 정확하게 같은 방법을 사용한다. 싱글레이션된 기  
판은 음파 영상을 위해 연구소에 보내졌다. 세라믹 칩 커패시터  
중의 대부분이 현재 내부에 균열을 가지고 있었으며 균열이 거  
의 수직이고 커패시터 단자와 평행되는 근처에 존재했던 것이  
음파 현미경을 통해 드러났다(그림 2). 이제 균열과 자기장 고장  
은 싱글레이션 공정이 진행되는 동안 발생한다는 것을 알았다.  
제조업자는 기판에 대한 기계적 응력을 줄이기 위해 싱글레이션  
공정을 바꾸었다. 그러자 자기장 고장의 근본 원인은 제거되었  
다. 싱글레이션 공정의 수정 후 어셈블리된 기판의 음파 영상은  
커패시터에 어떠한 균열도 일으키지 않음을 밝혀냈다.

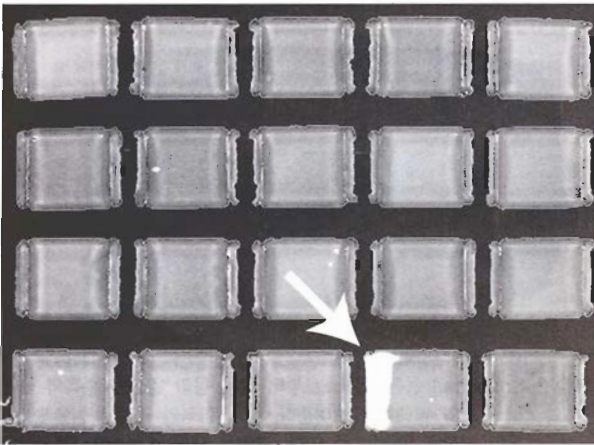
그림 3. 세라믹 칩 커패시터의 트레이 부품은 공급업체로부터 받은 많은 커패시터를 인증하기 위해 어셈블리 전에 음파적으로 영상화되었다. 하나의 커패시터는 큰 내부 균열(화살표)을 가지고 있다. 다른 소수의 커패시터는 작은 내부 보이드(작은 원의 하얀 부분)를 가지고 있다.

그림 3은 품질 조사되었던 세라믹 칩 커패시터의 트레이 부분의 음파 영상이다. 커패시터 중 하나가 큰 균열(밝고 하얀 부분을 갖고 있는데, 이 균열은 커패시터 끝 부분에 있고 아마 수직의 진행방향을 가진다. 만일 이 균열이 무작위 검사에서 발견되지 않으면, 그것이 PCB의 싱글레이션에 의해 발생한 균열이라는 것을 나중에 쉽게 진단될 수 있다. 表

그러나 어셈블러는 커패시터가 공장에 도착되었을 때 부품을 스크린하는 음파 현미경을 통해 균열된 커패시터의 유입을 막을 수 있다. 몇몇 어셈블러는 공급업체로부터 받은 수많은 커패시터를 인수하기 위해 음파 현미경으로 시험을 한다. 전형적으로 어셈블러는 들어오는 많은 커패시터의 몇 퍼센트를 조사하고, 결과에 따라 그것을 받아들일지 결정한다. 상당히 높은 신뢰성이 필요한 작업물의 경우 다른 경우와 달리 어셈블러가 커패시터의 100%를 조사한다.

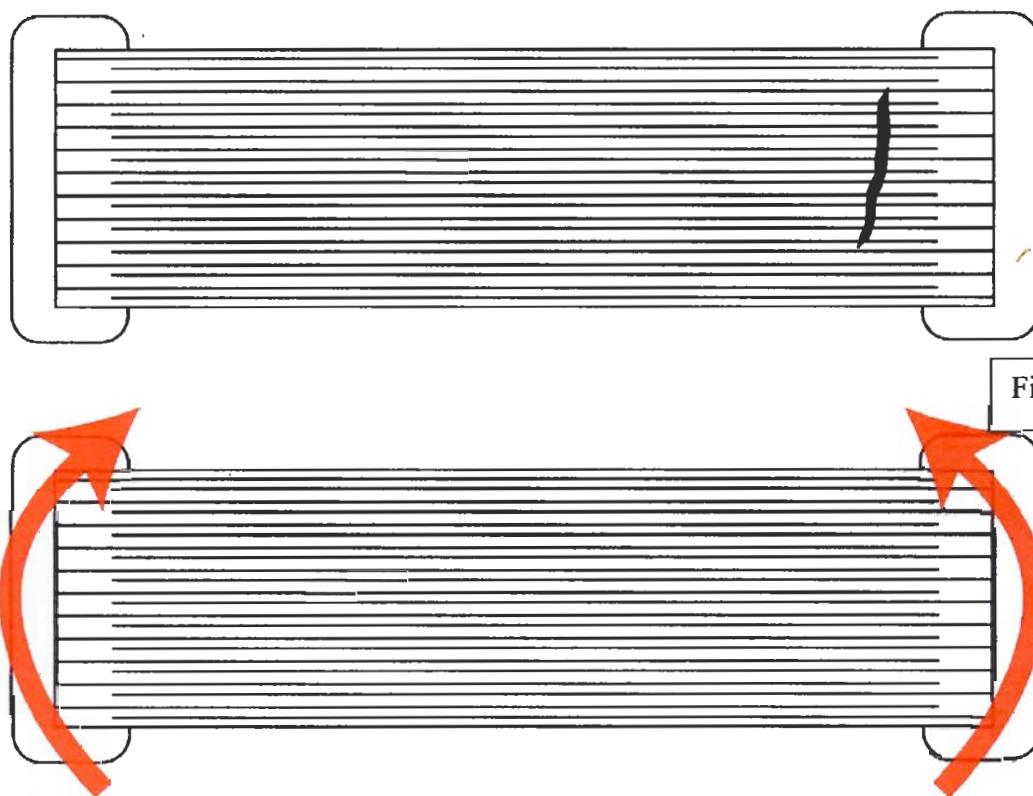
The laboratory technicians knew from long experience that vertical cracks near the terminations are often caused when printed circuit boards are snapped apart (singulated) at the end of assembly. When the boards are snapped apart, each board is bent slightly. The FR4 board is somewhat flexible, but the ceramic chip capacitor is very rigid, and the capacitor is strongly soldered to the board. The mechanical stresses from the bending of the printed circuit board are sometimes relieved by the formation of a crack in the capacitor [Figure 1]. Such a crack is typically vertical, near a termination, and does not always reach the surface of the capacitor, so it cannot be seen optically. Sonoscan's laboratory reported the images, and the interpretation of the images, to the manufacturer of the failed systems.

Figure 1 Flexing of the FR4 board during singulation puts mechanical stress (arrows) on the surface-mounted ceramic chip capacitor. If the stress is large enough, the result may be a vertical crack in the capacitor (top).

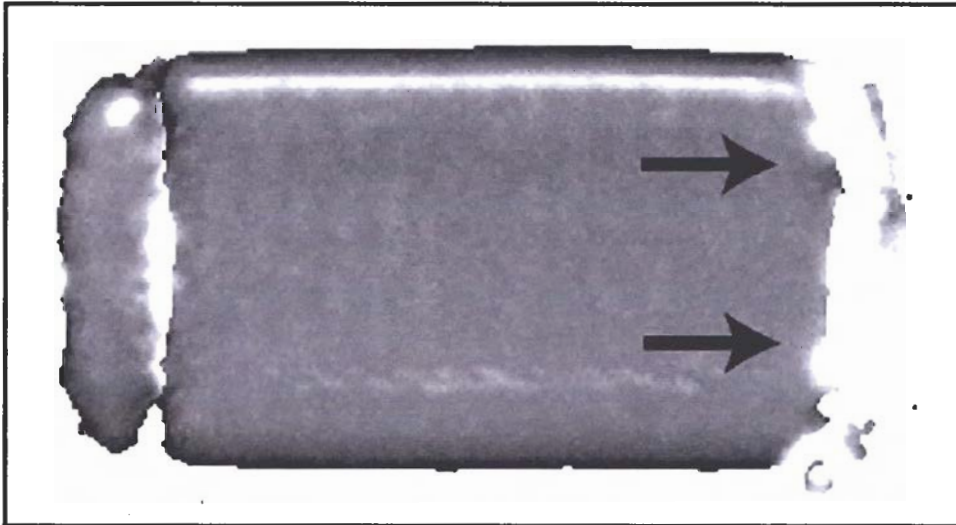
As a final step, the panels were then snapped apart, using exactly the same method that had been used to separate the boards that had failed in the field. The singulated boards were then sent to the laboratory for acoustic imaging. The acoustic microscope revealed that many of the ceramic chip capacitors now had internal cracks, that the cracks were nearly all vertical, and that the cracks were near the capacitor terminations and parallel to the terminations [Figure 2]. It was now clear that the cracks, and the field failures, were being caused by the singulation process. The manufacturer changed the singulation process in order to reduce the mechanical stress on the boards, and the root cause of the field failures was eliminated. Acoustic imaging of boards assembled after the modification of the singulation process revealed no cracks in the capacitors.

Figure 2 Acoustic image from Sonoscan applications laboratory shows a vertical crack parallel to the termination – typical of cracks that may occur when boards are snapped apart during singulation. The crack is bright white because it reflects virtually all of the ultrasound.

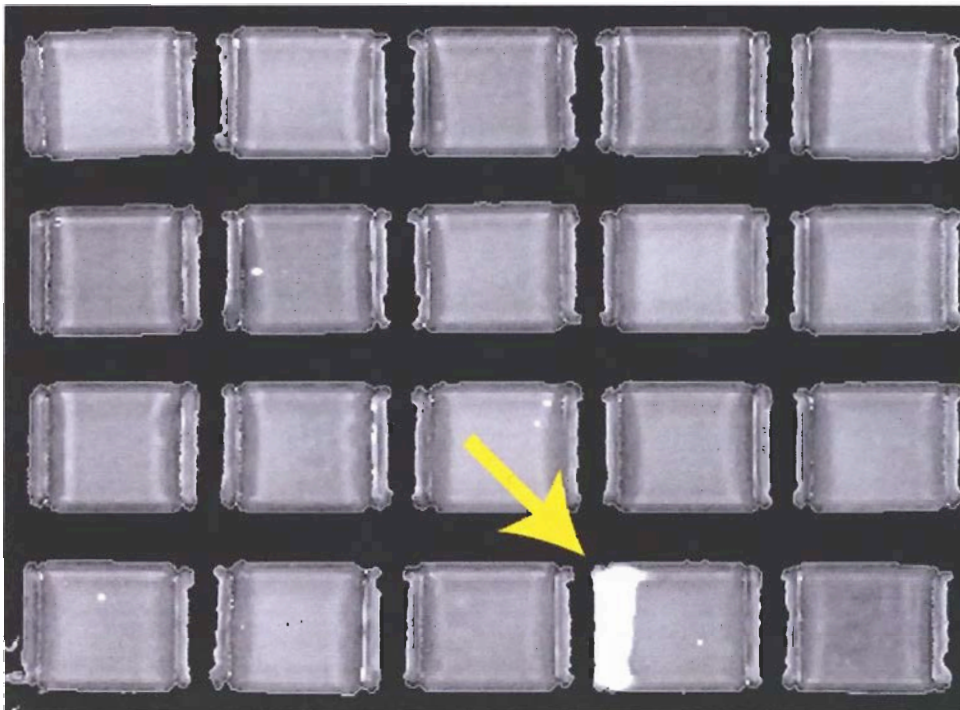
Figure 3 is the acoustic image of a portion of one tray of ceramic chip capacitors that were scanned to qualify an incoming lot. One of the capacitors has a large crack (bright white area); this crack is near the end of the capacitor and probably has a vertical orientation. If this crack were not

discovered in the incoming lot, it could easily be diagnosed later as a crack that had been caused by singulation of the printed circuit boards.

Figure 3 Part of a tray of ceramic chip capacitors imaged acoustically before assembly to qualify the lot of capacitors delivered by the supplier. One capacitor has a large internal crack (arrow). A few other capacitors have small internal voids (small circular white features).

But the assembler can protect himself against the cracks in incoming lots of capacitors by using an acoustic microscope to screen the parts when they arrive at his plant. Some assemblers use acoustic screening as a requirement for accepting the lot of capacitors from the supplier. Typically the assembler scans a percentage of the capacitors in an incoming lot and bases his acceptance on the results. In other cases, and especially where the reliability requirements are high, the assembler may scan 100% of the incoming capacitors.
