Characterization of Flip Chip Interconnect Failure Modes Using High Frequency Acoustic Micro Imaging With Correlative Analysis

Janet E. Semmens and Lawrence W. Kessler
SONOSCAN, INC.
530 East Green Street
Bensenville, IL 60106 U.S.A.
Tel: 630 766-7088 Fax: 630 766-4603

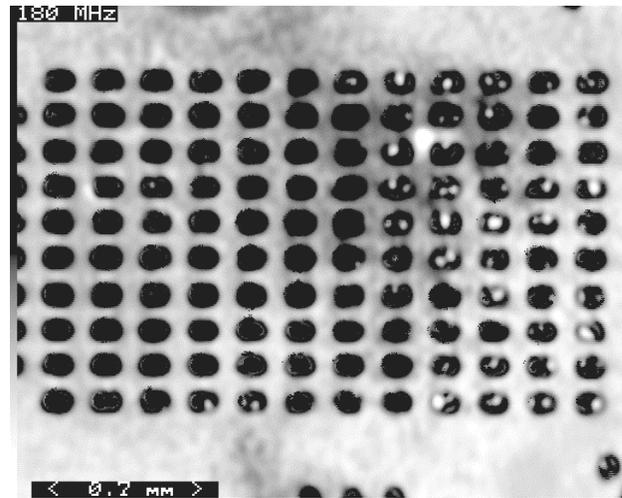
Figure 2 - 180 MHz acoustic image of flip chip bonds. Small voids at the interface appear as white features. Bonded bumps appear dark. A void (white area) is also present in the epoxy underfill

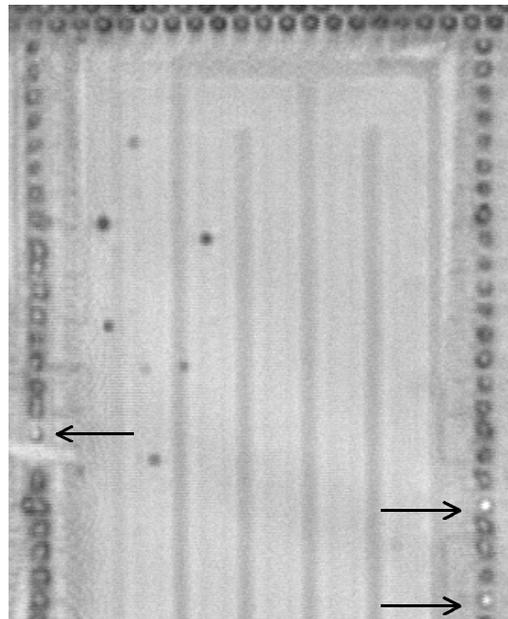
These samples were evaluated using 100 MHz. At first a technique was employed which looked through the solder joints to the substrate level (Figure 4). In this way any defect within the volume of the solder joint would cause a shadow in the image rendering it detectable. This method had been used in another study involving detection of failures in flip chip devices with promising correlative analyses^[3]. In the initial data set a large number of solder bond sites appeared dark in the acoustic images indicating the presence of defects.

Figure 4 - 100 MHz Acoustic image of the bump to substrate level through the chip side of the sample. In this image the entire volume of the bump is interrogated. There is a contrast reversal using this imaging method which causes the bonded bumps to appear bright. Bright areas indicate where the sound transmits through the entire thickness of the bump unobstructed. Defects at the chip/bump level or within the solder bumps above the substrate interface block the signal from the interface so the defective bumps appear dark.

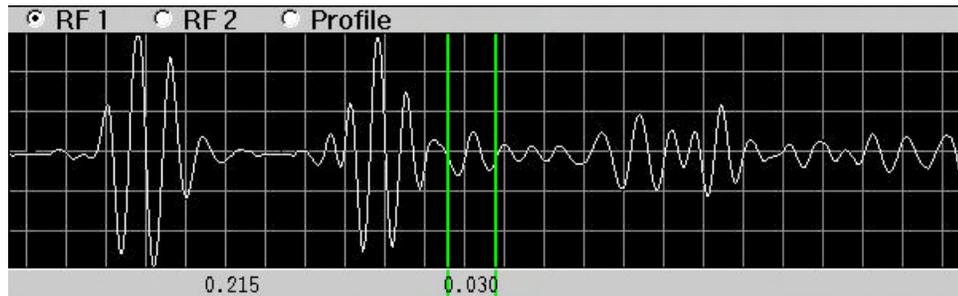
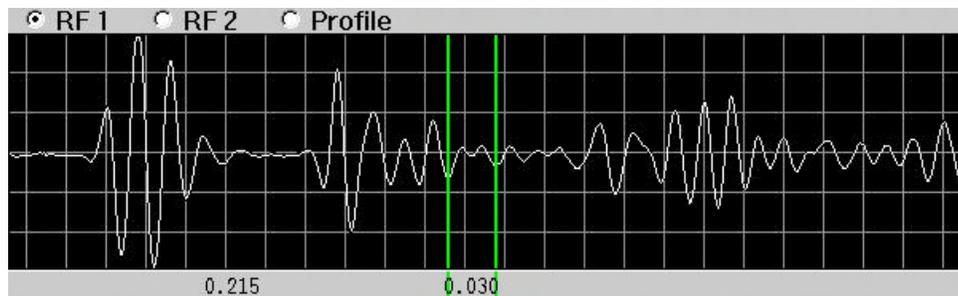
A-Scan in area of bonded solder bump.

A-Scan in area of defective solder bump.

Figure 5 - Example of 100 MHz A-Scans using the loss of back wall echo method. At this level the bond sites which do not contain defects show a signal within the gate and the bonds containing delaminations, voids and cracks show no signal in the gate.

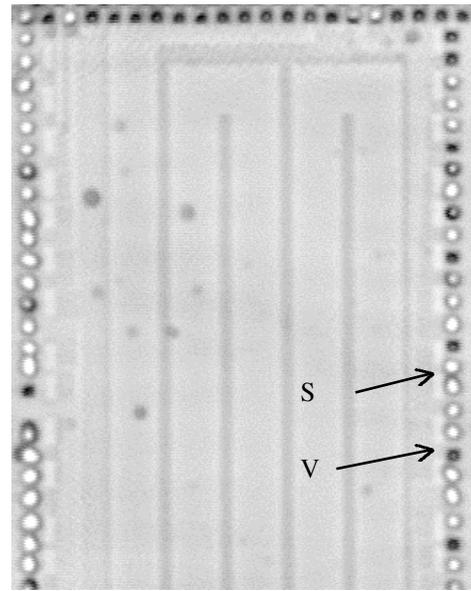
Figure 7 - Acoustic image of chip/bond pad level using level specific imaging technique. Now variations in the signal intensity are apparent from one bond site to another. In contrast to Figure 6 the parameters for this image cause the strong signal reflections characteristic of voids and delaminations to be shown in white. The white bumps also are the ones which display the larger, irregular shapes. Dark spots (low signal reflections) indicate the bonded pads at this level. Several of the sites are indicated by the arrows for reference in the corresponding DPA images.

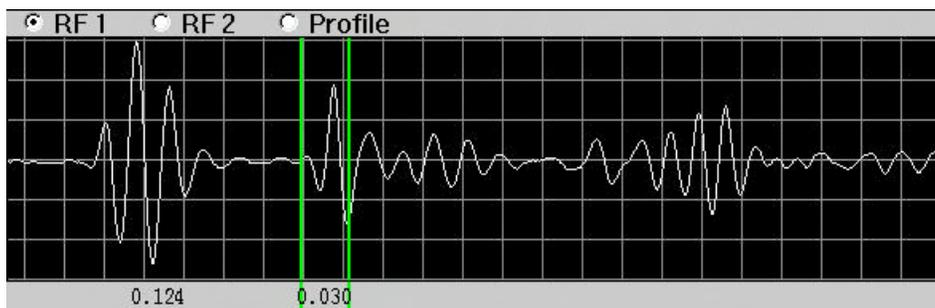
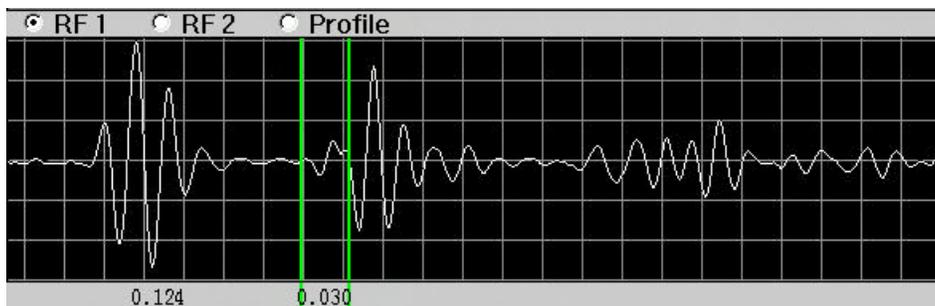
A-Scan corresponding to laminar crack under bond pad.

A-Scan corresponding to bonded pad.

Figure 8 - A-Scans showing the location of the gate (designated by the 2 vertical lines over the trace) to obtain the images of the bond pad and glassivation separations from the silicon. The echoes corresponding to the defects show a significantly higher amplitude than the echoes corresponding to the bonded pads.

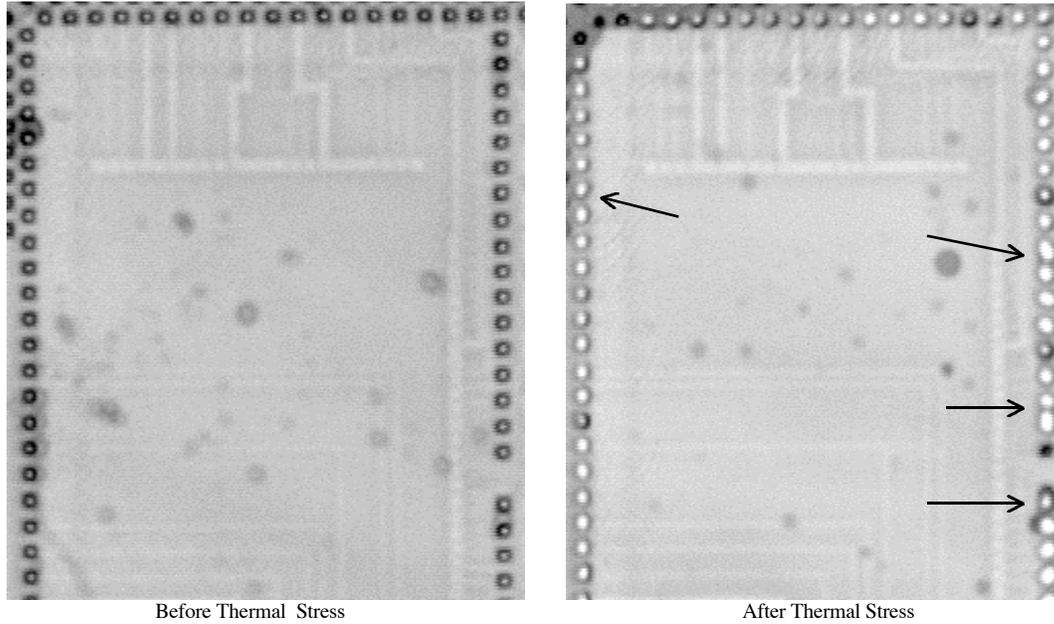
Another device of the same type which had not been thermally cycled was also evaluated acoustically using the same technique. The defects were not present in this sample at this time. The bond sites appeared uniform. This sample was subsequently thermally cycled and evaluated again acoustically after cycling. Now the device showed defects similar to the type seen in the previous sample. Figure 9 compares the acoustic image of the same device before and after cycling. Clearly the thermal cycling was inducing other defects in addition to the cracks in the solder balls.

Figure 9 - Acoustic images of the same device before and after thermal stress. The bond sites appear as dark circles, uniform in size before stress. After stress most of the bond sites now appear bright white and some are considerably larger in size and irregularly shaped. Examples are indicated by arrows.

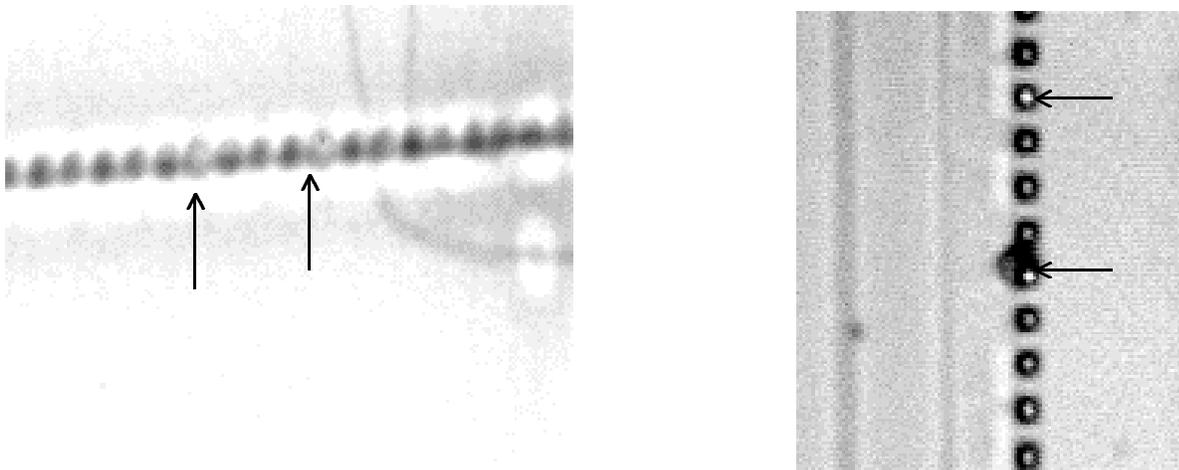
For the purposes of correlative analysis one of the thermally cycled parts was evaluated using micro focus x-ray (Figure 10). The x-ray results did not detect any cracks or delaminations but did show voids in some of the solder bumps. The voids could also be detected in the acoustic images of the device prior to thermal cycling (Figure 11). After thermal stress the defects induced by the cycling obscured this level from ultrasonic inspection.

Figure 10 - X-ray image of solder bumps. Two of the bumps appear brighter indicating the presence of voids.

These two bumps correspond with the bumps shown in the acoustic image.

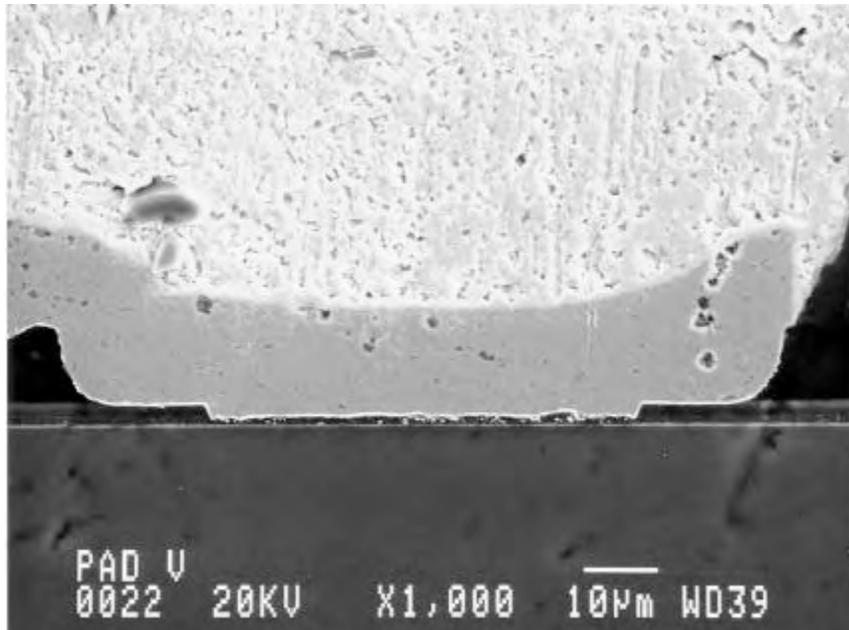
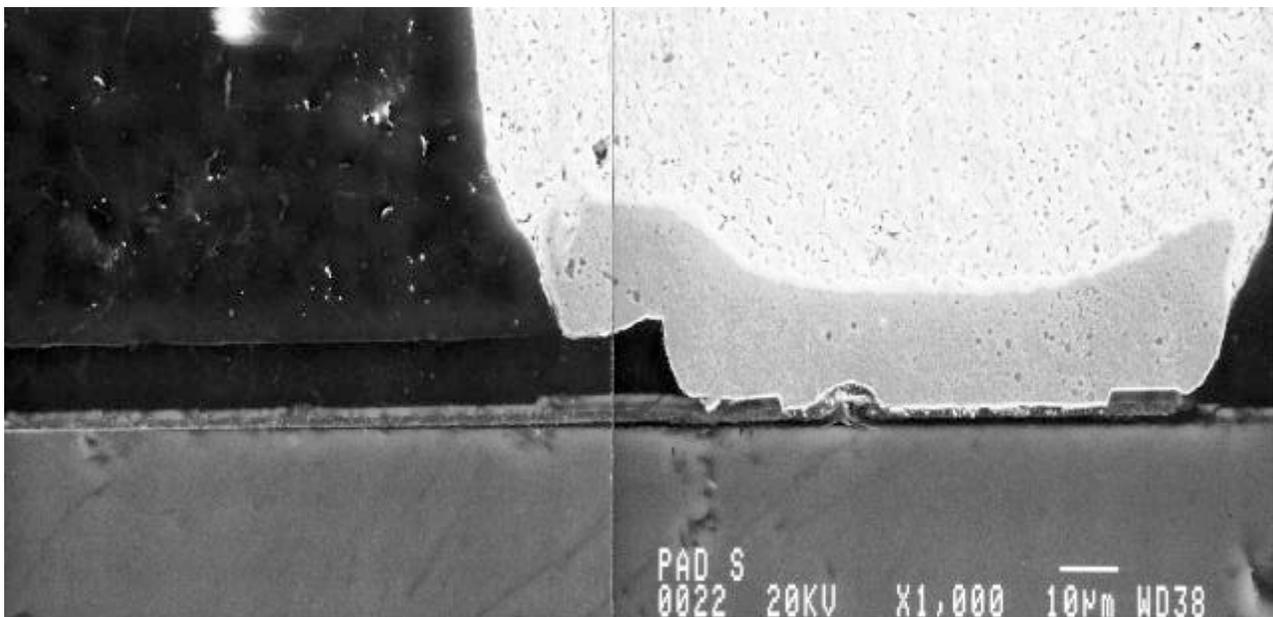
A thermally cycled part was cross sectioned and this time Scanning Electron Microscopy (SEM) was used to examine the section. The SEM evaluation did reveal the defects which caused the anomalies seen in the acoustic images. The defects were thin laminar cracks under the bond pads on the chip. In some cases the cracks extended out beyond the bump location under the glassivation layers (Figure 12). This is why some of the defects acoustically appeared larger than the expected size of the bond pads. A good correlation was

Figure 12 - SEM micrographs of DPA cross sections of bumps V and S shown in Figure 8. Site V appeared dark in the acoustic image indicating bond at this level. The DPA section shows no defects in the bond of the bond pad to the silicon or

glassivation layers. Site S displays a laminar crack under the bond pad. The crack extends under the surrounding glassivation layers. This bump appeared bright indicating a defect in the acoustic image.
