Cleaning up the flip-chip production act

Post-reflow cleaning processes significantly affect the uniformity of the underfill. Experiments carried out at Dexter Electronic Materials and, in part, at Kyzen Corp. with a single underfill material and multiple no-clean fluxes yielded results to support this.

[Printed Circuit Fabrication]

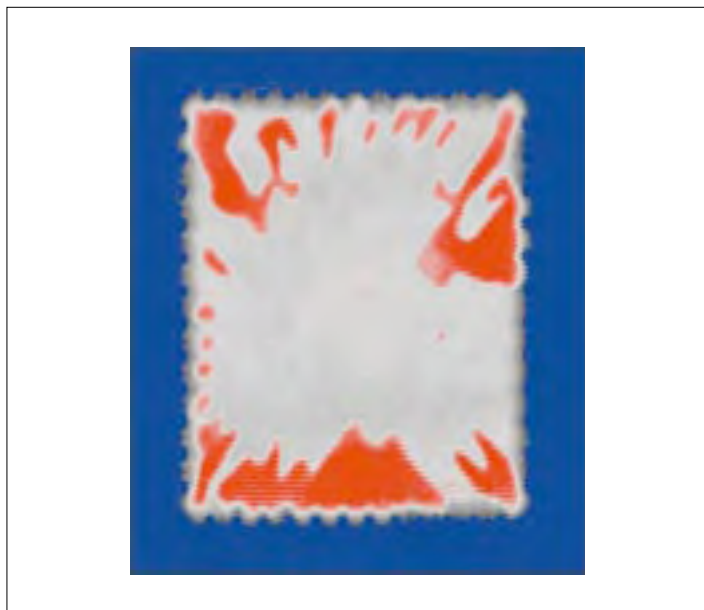
But after the 48-hour pressure cooker exposure, the results changed dramatically. Samples using one of the three flux materials showed significant delaminations when no cleaning was employed. Of the total of four cleaning processes (two cleaning agents used in each of two cleaning systems), one prevented the formation of delaminations, while a second reduced but did not fully prevent delaminations. More surprising was the finding that two

Flux residues, the tests suggest, may adversely affect the underfill flow process and result in striations and voids in the cured underfill. After pressure-cooker exposure, the same flip-chips were likely to form stress-related delaminations, apparently because inadequate cleaning leaves a weak interface of flux residue between the die surface and the cured underfill. Of the three flux materials, the one resulting in the lowest level of residue contamination also resulted in no striations, voids or delaminations. But this material is also less active than the other two flux materials and might not be suitable in all situations for yielding optimum solder joints. The other two flux materials—both more active—also left higher levels of residue. But both cleaning solvents were successful in removing flux residue from these two flux materials to acceptable levels.

Delaminations (red areas) between the cured underfill and the die face, imaged acoustically after stress testing.

This study points out that compatibility of materials in flip-chip production is extremely important. The cleaning solvent and the cleaning process in particular must be able to remove flux residue without creating additional defects. The study also suggests that a cleaning step may be advisable even when no-clean fluxes are used.
