Preventing flip-chip solder joint failures

[High-Density Interconnect]

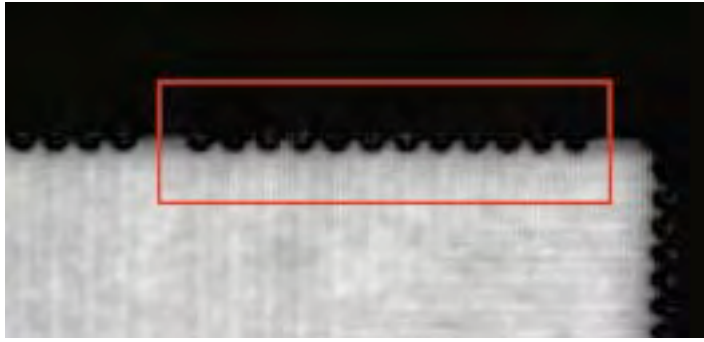
Figure 1: Acoustic image of one corner of a test chip before thermal cycling. Solder joint bonds are dark and it merges into the background since there are no fractures.

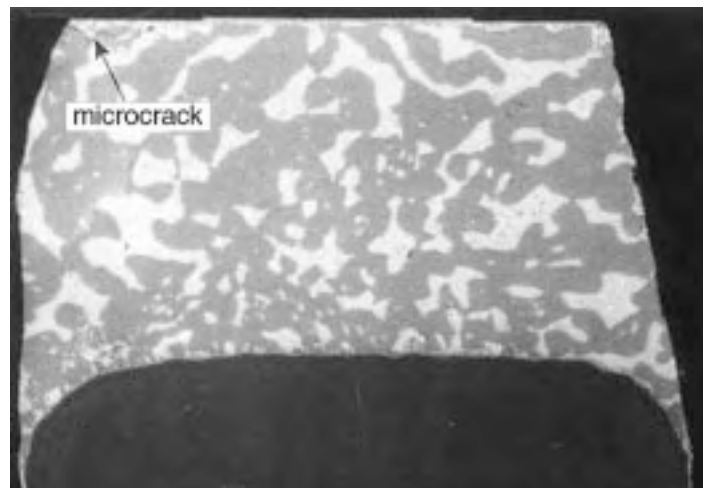
Figure 3: Crack initiation visible in a cross-sectioned solder joint where acoustic imaging had indicated crack formation.

For a solder joint in which crack initiation has just begun, you can find some coarsening effects on the microstructure. This coarsening is more pronounced near the interface between the solder joint and the die face at the top of the photo. Finite element simulations in previous studies have shown that coarsening of the microstructure induces strains in the solder. Both coarsening and strain are most prevalent in the area of the bump nearest to the chip face.

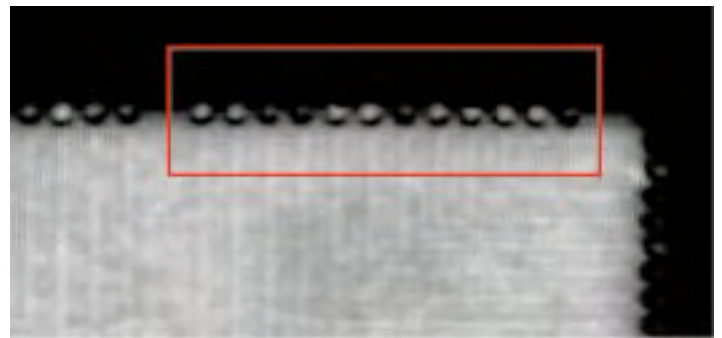
Figure 2: Test chip imaged acoustically after 772 thermal cycles. The solder joints show varying degrees of brightness, corresponding to the percentage of the bond area that has cracked.

All of the solder bump bonds are dark, indicating low contrast and therefore good bonding. After 772 thermal cycles, several solder bumps in the acoustic image of the test chip have become much brighter. These bumps display varying degrees of brightness that correspond to the area of the crack

Significantly, these cracks are forming in the absence of a delamination, which would be visible acoustically because, like a crack, a delamination represents a gap-type feature that would reflect nearly all of the ultrasound. To learn more about the formation of the cracks, some of the test chips that displayed cracks acoustically were physically sectioned, then examined and photographed with a metallographic microscope.

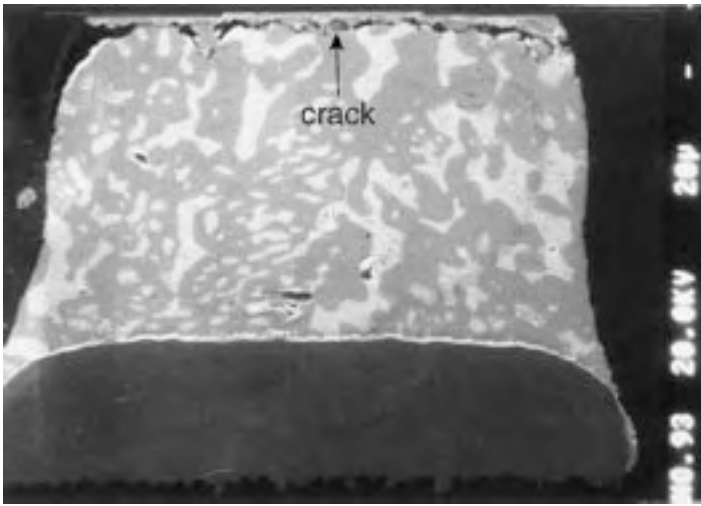
Figure 4: Complete cracking of a solder joint across the region of greatest coarsening of the solder.

additional thermal cycling, the result of additional cycling may not be just a larger crack, but faster propagation of the crack across the solder bump.

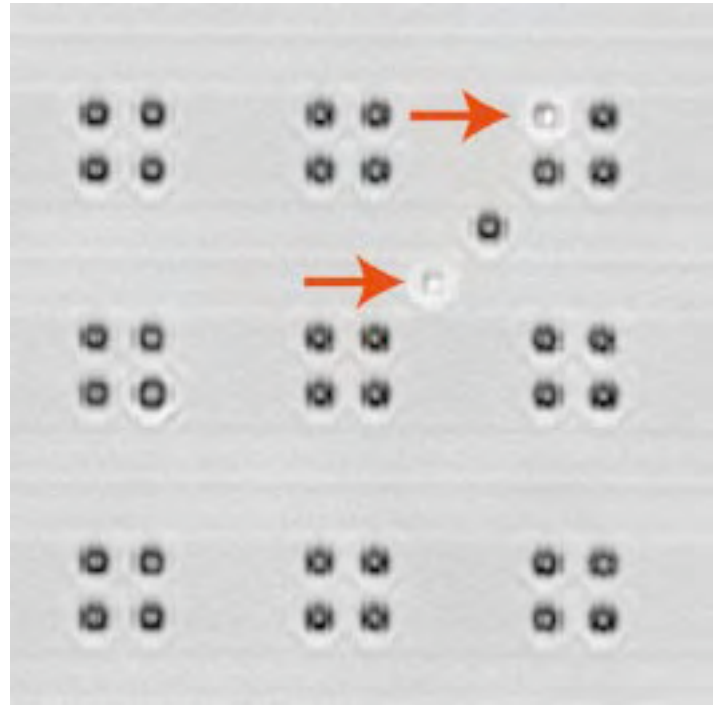
Figure 5: Ultrasonic reflectivity of solder joints at the interface to the die.
