Preventing flip-chip solder joint failures

In order to shed more light on the degradation of solder joints in FCOBs, a joint research project was undertaken between DaimlerChrysler SIM Technology and DaimlerChrysler Research Institute. The focus of the study was on the degradation of solder joints over time as a result of thermal cycling. Thermal cycling exaggerates the already large difference in the coefficient of thermal expansion between the substrate and the silicon die. Strains caused by thermal cycling are most severe at the corners of the die. The study also sought answers to specific questions: How are solder joint cracks initiated? How do these cracks propagate? What is the role of micro-structural coarsening of the solder joint?

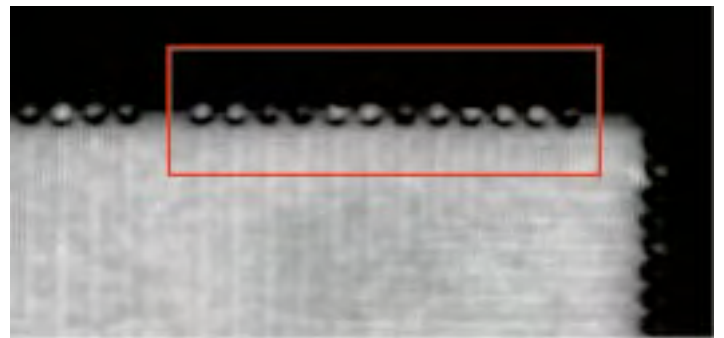
Figure 2: Test chip imaged acoustically after 772 thermal cycles. The solder joints show varying degrees of brightness, corresponding to the percentage of the bond area that has cracked.

All of the solder bump bonds are dark, indicating low contrast and therefore good bonding. After 772 thermal cycles, several solder bumps in the acoustic image of the test chip have become much brighter. These bumps display varying degrees of brightness that correspond to the area of the crack

in each bump.

Significantly, these cracks are forming in the absence of a delamination, which would be visible acoustically because, like a crack, a delamination represents a gap-type feature that would reflect nearly all of the ultrasound. To learn more about the formation of the cracks, some of the test chips that displayed cracks acoustically were physically sectioned, then examined and photographed with a metallographic microscope.
