Swift Acoustic Inspection Rescues BGAs

Staff -- 10/1/2002
EP&P

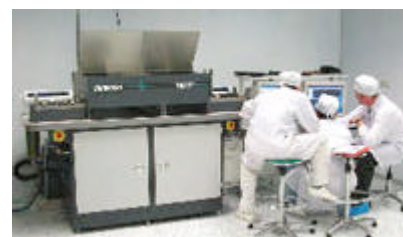
When a contract manufacturer discovers that the heat of the reflow process is causing damage to IC packages, the hunt begins for the root cause of the problem — which could be in any of numerous earlier process steps. In the case of the damage occurring at an Asia contract manufacturer, the unknown cause of the problem seemed to originate with the maker of the plastic BGAs. The maker of the BGAs examined its processes and soon learned that the problem consisted of delaminations in the BT substrate. The BT substrate, in turn, was being supplied by a third company. The very thin delaminations, it was found, were present in the BT substrate when delivered by the vendor to the BGA maker

After encapsulation of the BGA by the manufacturer, the moisture that permeates all plastic packages was finding its way to the delaminations. During reflow by the contract manufacturer, this moisture was flashing into steam and the resulting pressure was destroying the BGA.

The tug-of-war between the BGA maker and the vendor was finally resolved when the vendor agreed to use an automated system to perform 100 percent inspection on the BT substrates before shipment to the plant. This

solution positioned the solution to the problem at the earliest possible point in the process sequence, and permitted the vendor to maintain the current pricing structure. The manufacturer's evidence that the problem had been solved came in the resulting precipitous drop in the number of BGAs suffering damage during reflow.
