# Acoustic Detection of Package Contamination

Able to image the interface between the package and die, acoustic imaging detects defects, contamination and molding compound issues.

**Tom Adams and Ray Thomas,**  
Sonoscan Inc.,  
Elk Grove Village, Ill.,  
[www.sonoscan.com](http://www.sonoscan.com)

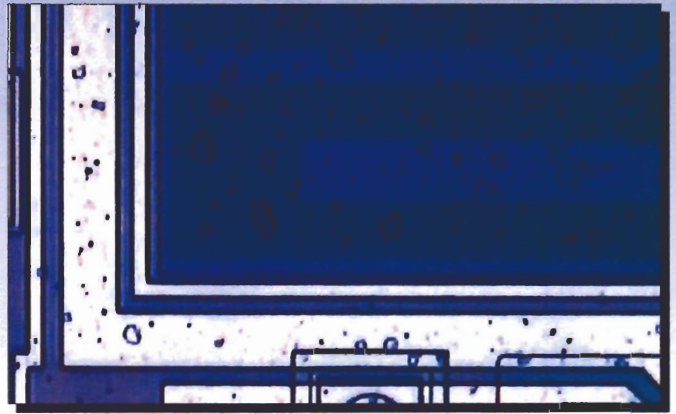
**3.** Surface of the die after dry decapping. Small irregular areas are the residue of a contaminant. Auger electron spectroscopy showed the presence of silicon, carbon and oxygen, suggesting that the contaminant may have been a silicone. (Source: Riga Analytical Lab Inc.)

The die face was examined next (Fig. 3) by Auger electron spectroscopy (AES). A dry residue was noticed on the die face.

The AES surface analysis of the residue on a bond pad was carried out first without treatment, and then after ablative sputtering with argon ions to remove 20 and 50 Å of material. Comparison with a similarly evaluated control sample showed that carbon, oxygen and silicon were all present in greater concentrations than in the control sample. Identification of the residue as an organic compound suggested that the fluid contaminant in the delamination may have been any of various types of silicone, whose molecules consist of SiO and an organic radical. A silicone is used as a releasing agent in the molding process to facilitate ejection of the parts. The possibility exists that silicone from this source is making its way onto the die face before encapsulation. Bromine was also present in the EDX analysis, because it had most likely leached out of the molding compound.
