Light and sound: LEDs seen acoustically

By **TOM ADAMS**, Sonoscan, Inc., Elk Grove, IL

Many LED failures are the result of voids or other gap-type anomalies that block heat flow from the die.

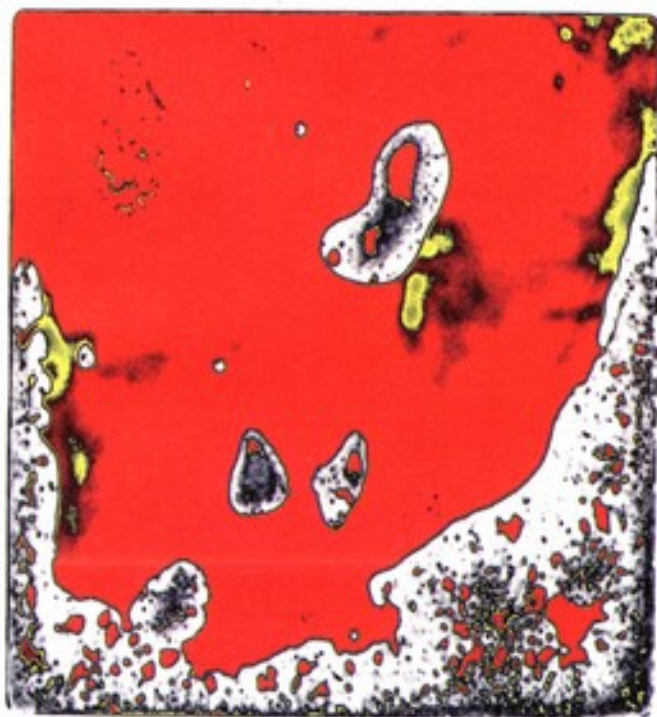
FIGURE 1 is a high-resolution acoustic image of the solder layer between the substrate and the heat sink of an LED. The transducer of the acoustic micro imaging tool traveled back and forth just above this wafer at a speed that can exceed 1 m/s. Each second the transducer repeated its pulse-echo function thousands of times, pulsing ultrasound into the wafer and receiving the return echoes from material interfaces - homogeneous materials generate no echoes. The amplitude of each echo is recorded, and will determine the pixel color for that x-y location. Most material interfaces are between two solids, reflect roughly 20% to 80% of the ultrasound, and in monochrome images produce dark gray to light gray pixels.

FIGURE 1. Red regions in this acoustic image are voids in the solder bonding the heat sink to an LED.

In the polychromatic color map used here, only in the white areas is the solder bonded to both the substrate and the heat sink. Red regions are not bonded, and thus contain an air gap and reflect virtually all of the ultrasound. More than half of the intended contact area is not bonded, a situation that might be acceptable for a mid power LED, but not for a high power LED. If the non-bonded area

grows in size -- as they tend to do after thermal cycling -- this LED may overheat and fail. If it is a mid power LED assembly, though, the failure of some units may have been anticipated and overall performance may remain within acceptable limits.
