COMPOUND SEMICONDUCTOR

Solid-state lighting

Uncovering
imperfections in
LED packages

Unveiling structural anomalies in LEDs

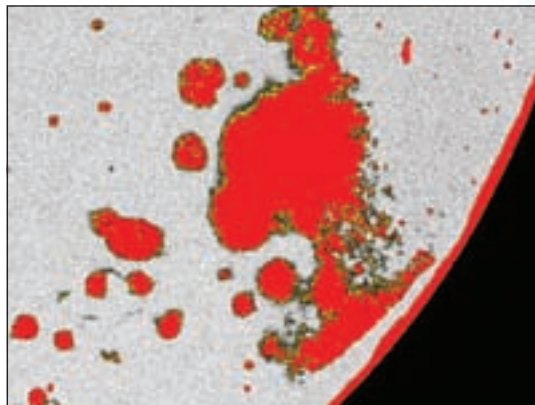
Figure 1. Sonoscan's S-CAM acoustic imaging tool reveals gap-type defects (shown in red) in a LED wafer with a sapphire base

An example of the capability of our tool is provided in Figure 1, which shows, in very high resolution, an acoustic image of a small portion of one LED wafer. Pale grey regions indicate an absence of defects, while red features represent regions of high-amplitude reflections. These areas consist of numerous tiny gap-type defects, such as delaminations, located between various layers built up on the substrate.

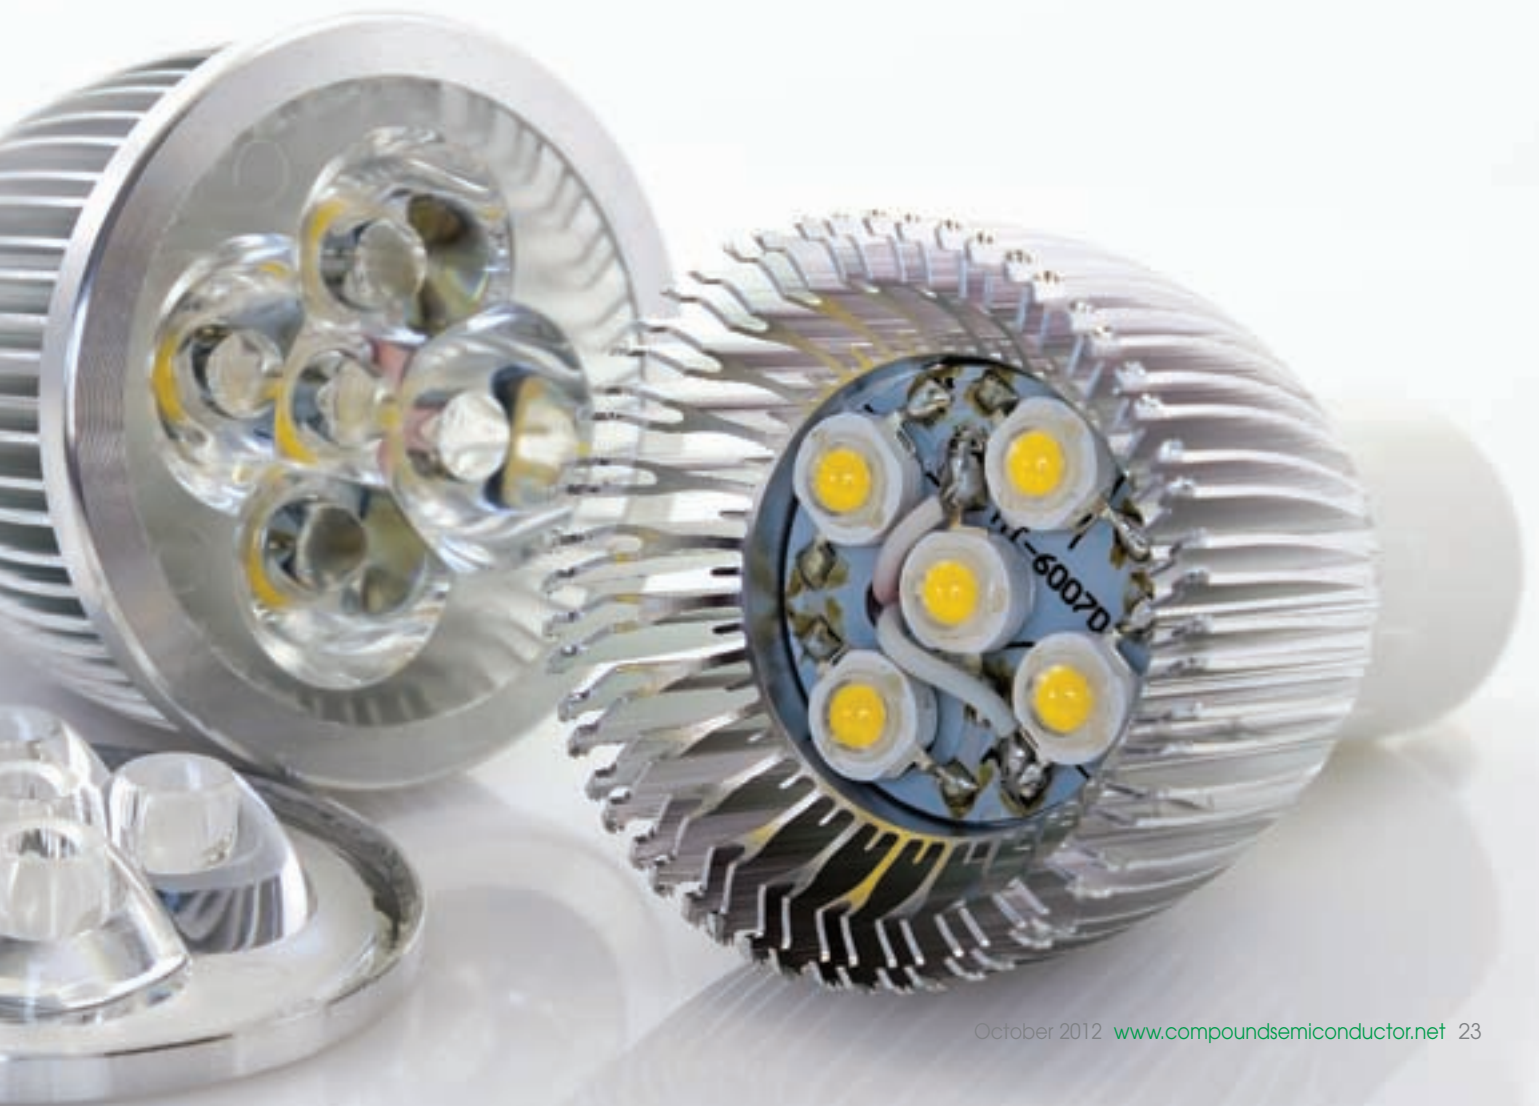
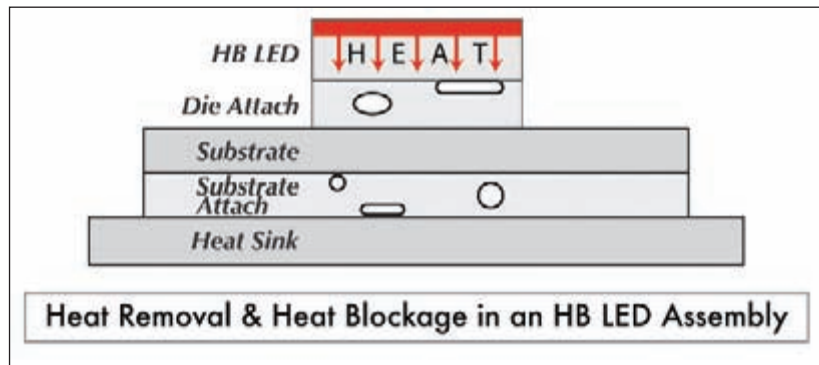
Figure 2. The intended pathway for thermal dissipation from a single LED is downward (red arrows) to the heat sink at the bottom. Gap-type defects, chiefly in the attachment materials, block heat and lead to early die failure. Note that the gaps shown in this figure are greatly exaggerated in their vertical dimension; gaps that are effective heat blockers and that provide high-amplitude reflection for acoustic imaging can be as thin as a fraction of a micron

Common features of a completed LED assembly include one or more LED chips, die attach material for bonding the LED to a substrate, and attachment material for bonding the substrate to a heat sink (see Figure 2).

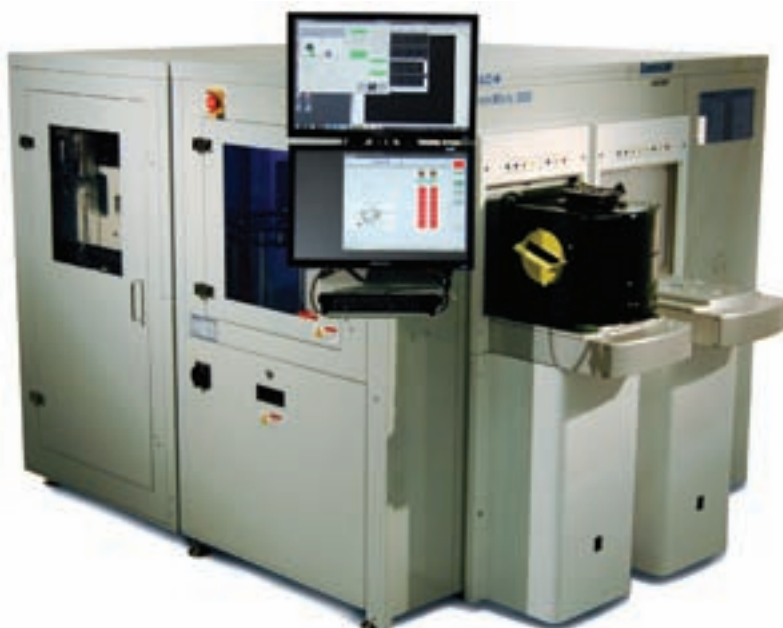
Left: Based on Sonoscan's well-known C-SAM acoustic microscope systems and launched in 2011, the AW300 300 mm bonded wafer inspection system automates the entire inspection system from carrier attachment and wafer selection through aligning and acoustic imaging to drying and sorting. Analysis software automatically measures the percentage of bonded and unbonded interface between the two wafers, and the sizes and number of voids. Accept/reject decisions are made automatically according to the user's specific criteria

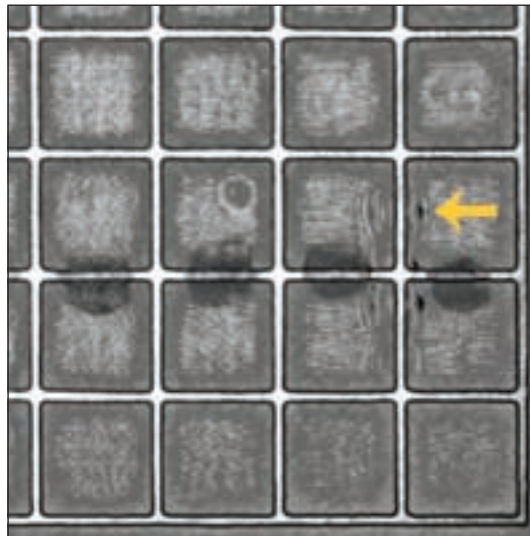
Figure 3. Acoustic imaging performed on the topside of an array of LEDs can reveal cracks, such as that highlighted by an arrow, in the sapphire chips. This array had no lens, and the depths of interest were the LEDs and their attachment to the substrate

Structural defects that are not related to heat removal can also be revealed in acoustic images. For example, images of one corner of an LED array can show features that are probably vertical cracks in the die (see Figure 3, which has a yellow arrow that marks out one of these features).

In addition, there are some lighter-coloured features of similar structure in same area, which are probably cracks that reflect ultrasound differently, due to variations in

depth and orientation; and there are four round, dark features, which are electrical connections below the die. The die themselves display a light-to-medium grey texture, indicating that they are well bonded to the substrate. There are no bright areas here that could indicate the presence of voids or disbonds (the latter are separations at an adhesive bond line in a bonded joint).

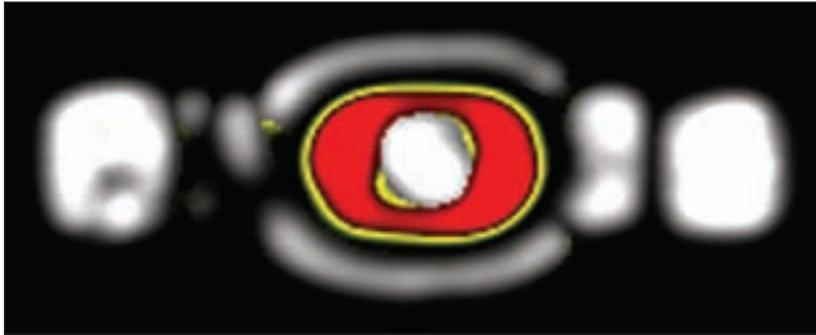
Figure 4. After the lens has been ground flat, topside acoustic imaging of this tiny LED can reveal essentially total delamination of the polymer from the substrate

Pulsing ultrasound through the remaining polished lens material revealed that the square shape of the die, at centre, is somewhat distorted, due to wires attached to its upper right and lower left corners (see Figure 4).

This image also shows the leads, which appear as large white features on the left and right. The red region completely surrounding the die reveals that the polymer is completely disbonded from the substrate below the die. It is possible that the disbond may already extend into the die attach material below the die, where it would reflect heat back to the die.

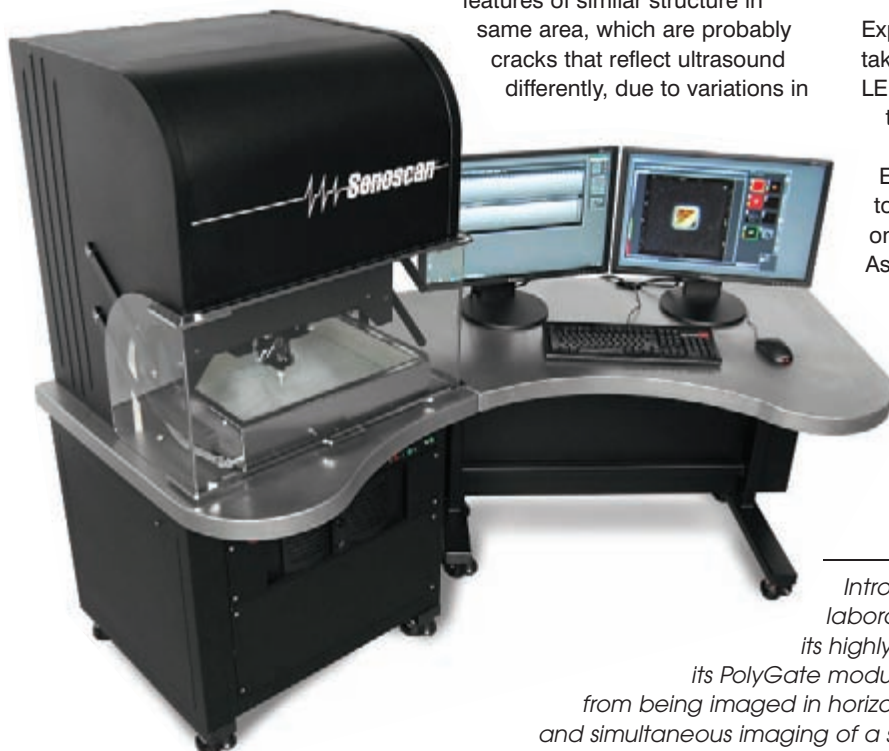
Introduced in 2011, Sonoscan's Gen6 high-end laboratory acoustic microscope is best known for its highly intuitive Sonolytics software interface and its PolyGate module. Certain samples and materials benefit from being imaged in horizontal "slices." PolyGate permits automatic and simultaneous imaging of a sample at up to 200 different gates (horizontal "slices")
