Presented at
Apex 2000
March 14-16, 2000
Long Beach Convention Center
Long Beach, California
© IPC 2000

High Frequency Acoustic Micro Imaging For Process Monitoring and Quality Control In Flip Chip Underfill Assembly

Janet E. Semmens and Lawrence W. Kessler
Sonoscan, Inc.
Elk Grove Village, IL

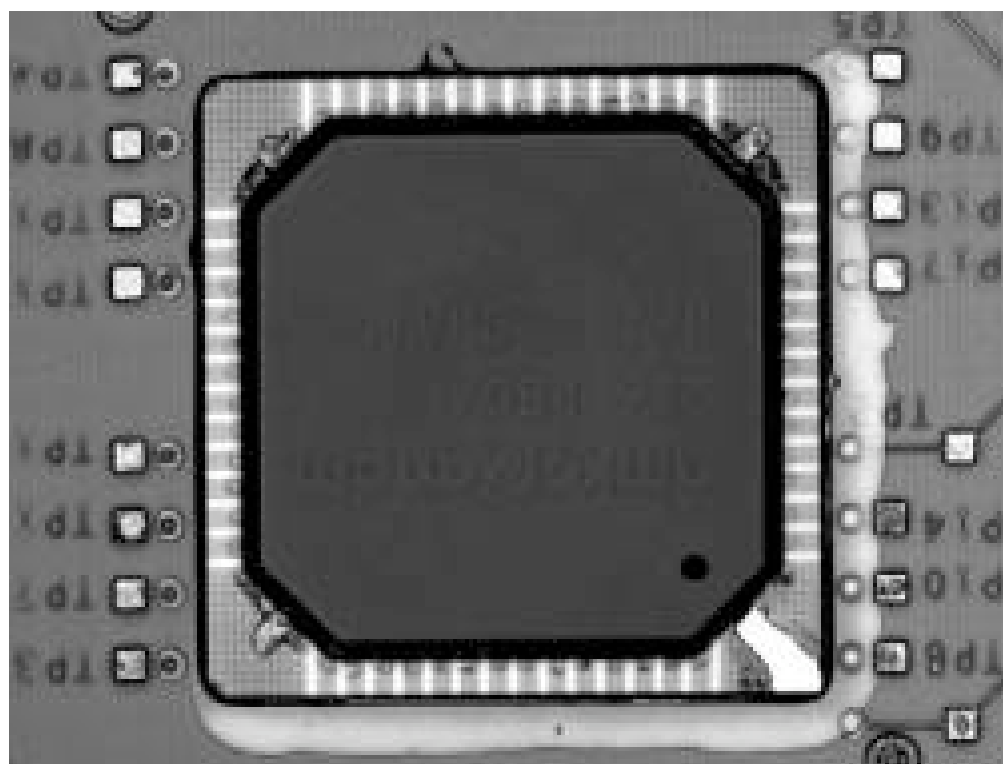
Figure 4a – Shows an Acoustic Surface Scan of the PBGA

The excess flow from the underfill can be seen at the right side and bottom edge of the part.

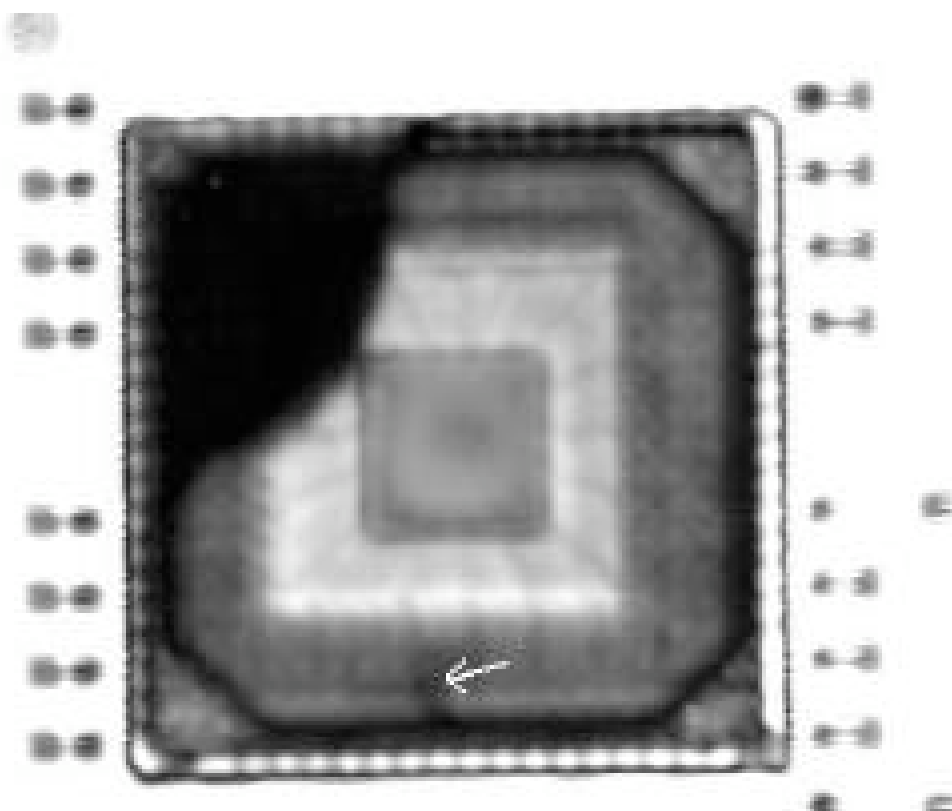
Figure 4b – The Through-Transmission Image of the Board

Underfill and PBGA shows a large dark corner that corresponds to a void in the underfill. A smaller void is also present (arrow). The influence of the structures in the BGA and the board are also seen in the image.

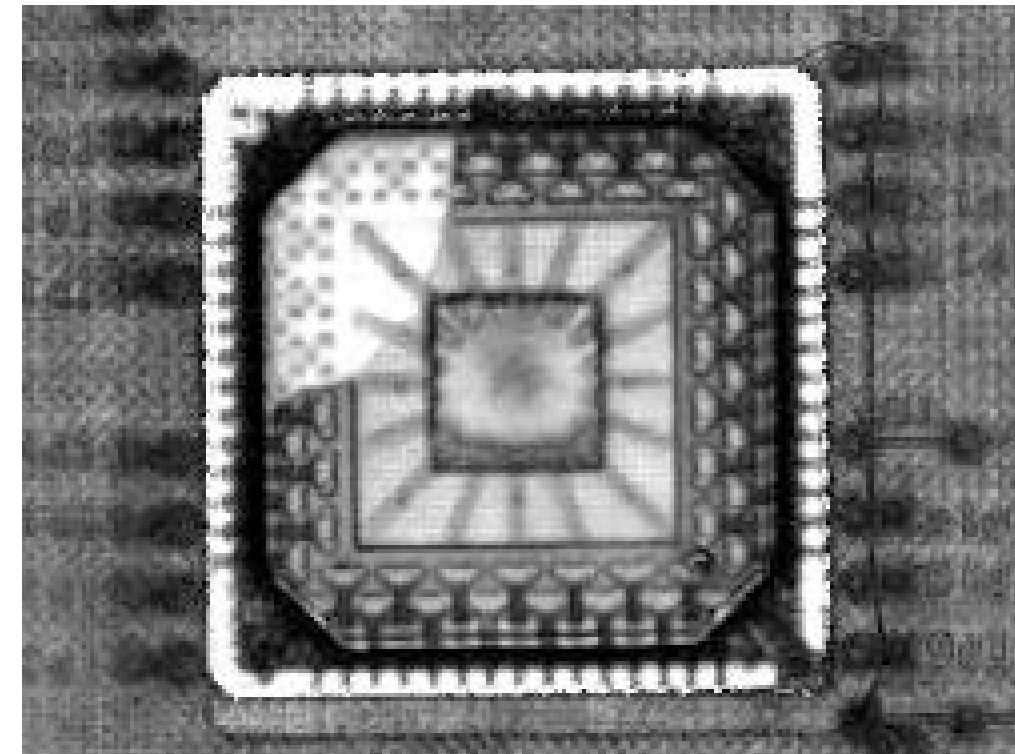
Figure 5 – Reflection-Mode Image at the BGA Package to Underfill Level

The bright white corner corresponds to the large void in the underfill between the package and the board. The smaller void (seen in the through-transmission picture) is not present in the image of this level. The smaller void was found to be at the underfill/board interface.

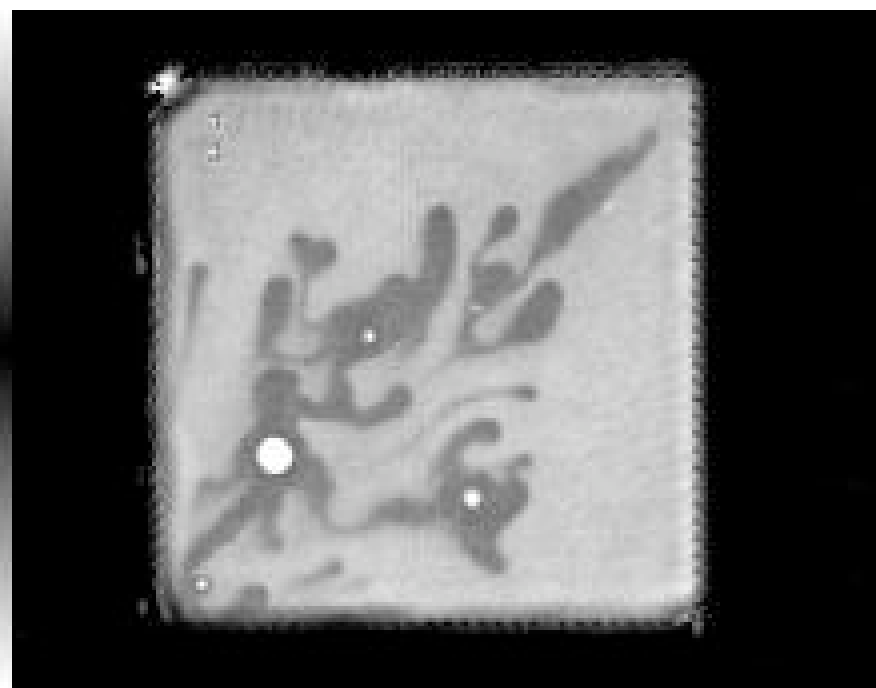
Figure 6 - The Darker Areas Indicate Regions of Higher Filler Particle Density

Based on the pattern the dispense of the underfill was along the top and right sides. The voids are the white features within the areas of higher particle density.

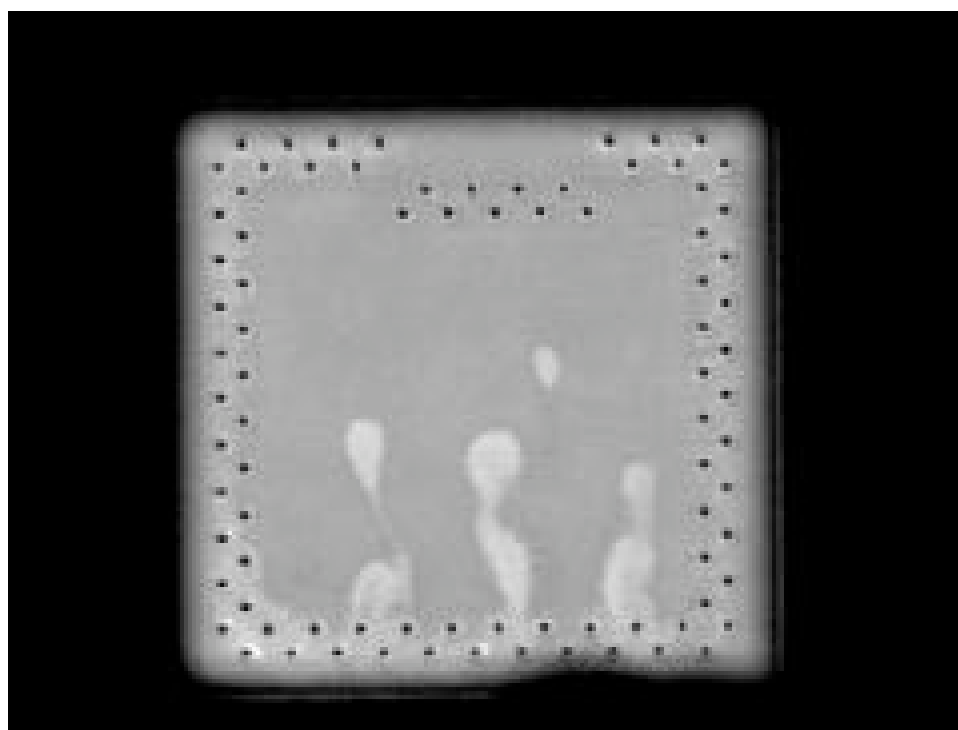
Figure 7 - The Filler Particle Pattern in This Sample Appears as Lighter Grey Regions

In these regions the particles have settled closer to the substrate. The dispense pattern was along the top edge of the device in the image. Small "halo" voids (white features) are seen in the proximity of several solder bumps.

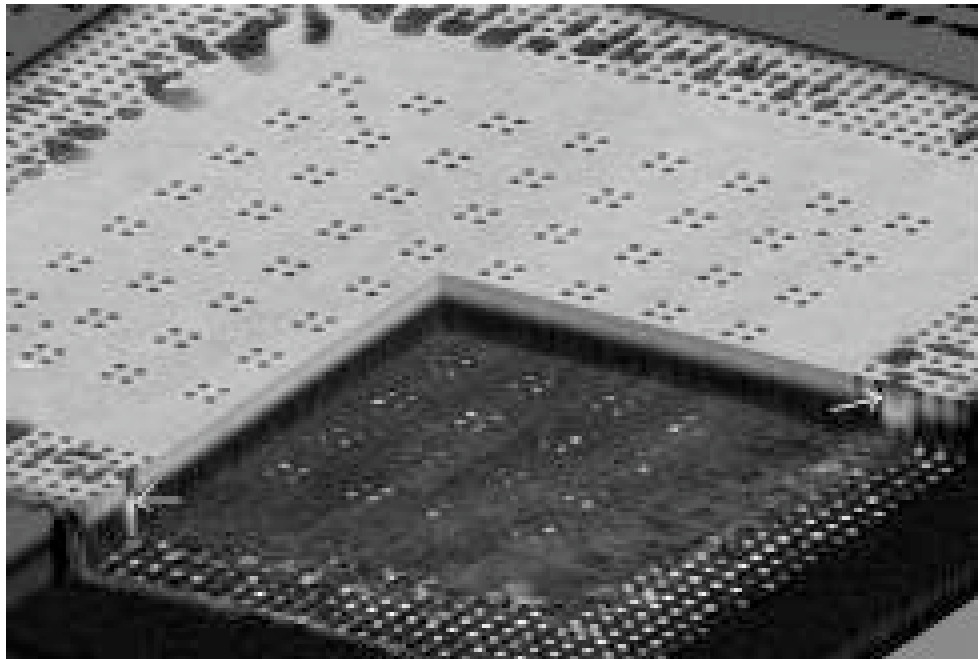
In the first 3V example (shown in Figure 8) voids are present in the underfill but most of the voiding occurs just below the chip/underfill interface rather than at the interface. Destructive interference results from the chip/underfill and underfill void signals causing the voids to appear as less signal in the chip/underfill image. The strong reflections characteristic of voids are not seen until subsequent levels in the underfill are imaged. The voids could be mistakenly interpreted at the chip/underfill level as variations in filler particle concentration if the subsequent images were not available. The cutout in the 3D reconstruction shown in Figure 8 illustrates the offset in the depth of the voids relative to the chip/underfill interface. Some flip chips contain a polyimide layer on the die and the coating causes the offset in the position of the silicon/bump versus the die coat/underfill level. However, in this device some voids were observed at the inner surface of the chip suggesting that this chip did not contain a polymer die coat. It is interesting to note that there are a large number of voids and that the location of the voids is concentrated in the proximity of the bump interconnect sites at the perimeter of the chip. There is no voiding detected in the central area of this sample.

Figure 8 - A Reconstruction of A Flip Chip Sample Beginning with the Chip/Underfill And Bump Level Down to the Underfill and Bump to Substrate Interface is Shown in this Image.

The reconstructed sample has been cut out at one corner to show the variation in depth of two voids in the underfill (arrows).

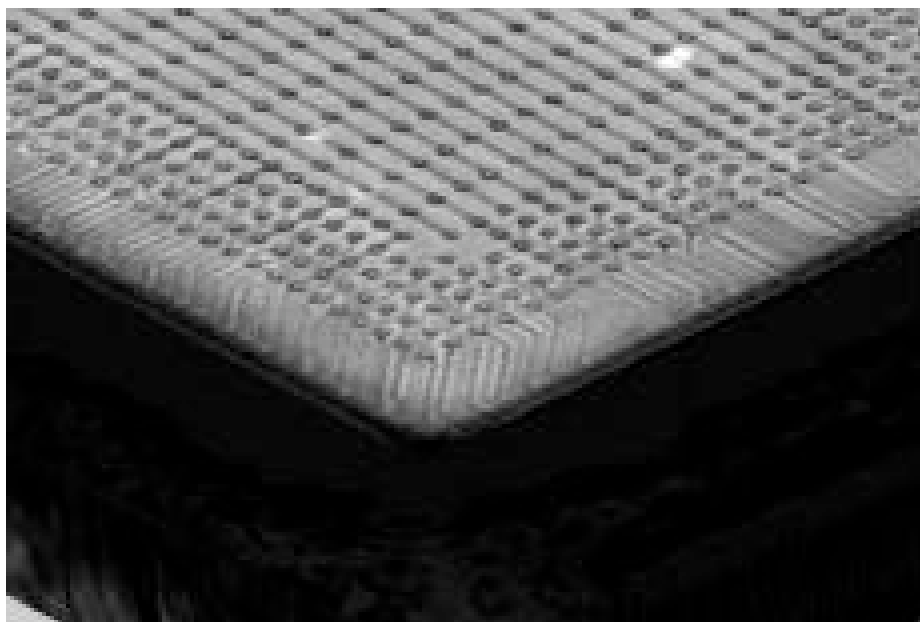
Figure 9a - The Image Displays the Reconstruction Before Sectioning

The chip to underfill and bump level is displayed showing the metallization on the chip and bond sites. White features indicate voids at the interface.

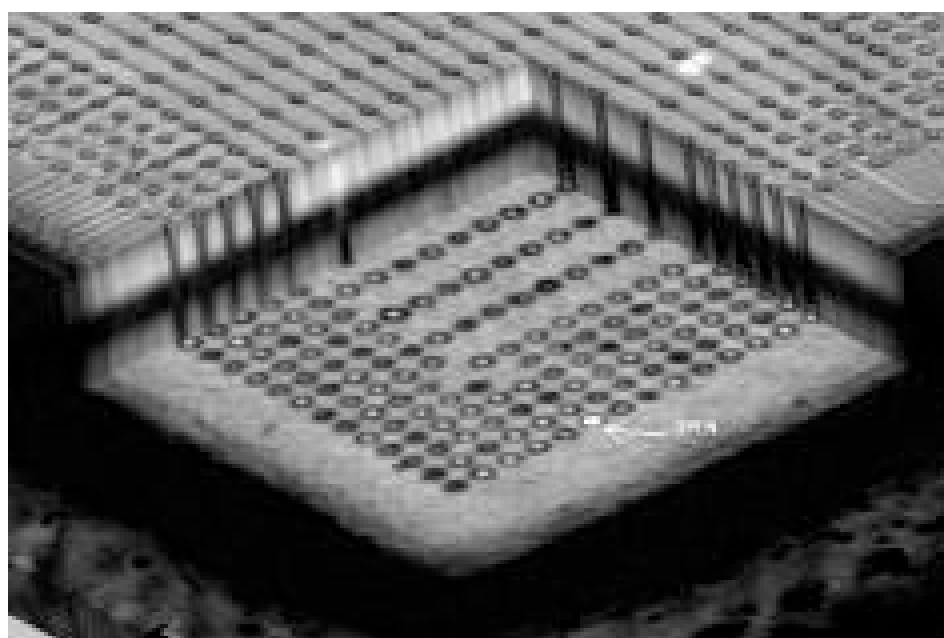
The second example, Figures 9a and 9b, show another flip chip with underfill. Figure 9a shows a corner of the reconstructed sample prior to "sectioning". Only the chip/underfill and bump level is visible. A void is present at this level as a white feature. Figure 9b shows a cutout section that reveals additional features at deeper levels in the sample. Again there is an offset to the depth position of some of the voids compared to the silicon/underfill interface and the depth of the voids is not due to a die coating. There are only a few voids in this sample but the proximity of the voids to the bumps would be cause for concern. In this sample one of the bump bond sites appears brighter than the surrounding bumps indicating a strong signal reflection. This bump corresponds to an open site that was also detected by electrical testing. Note that the bump is bonded at the chip/bump level shown in Figure 9a.

Figure 9b - Shows a Cutout of the "Virtual" Flip Chip Now Reveals a Void Below the Chip/Underfill Interface and an Open Connection at the Bump/Substrate Level
