Eliminating electronic failures is about the little things

Mar 1, 2010 12:00 PM, **Tom Adams**
 Consultant
 Sonoscan, Inc
 Elk Grove Village, IL
sonoscan.com

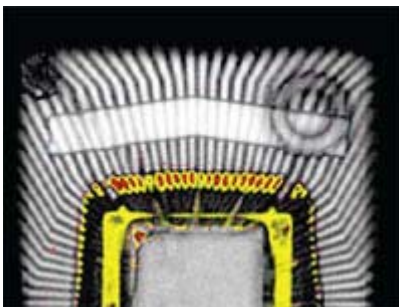
Figure 4. Delaminations (red features) at inner ends of lead fingers, perhaps caused by using a mold compound that does not adhere well to silver.

[Figure 4](#) is the acoustic image of one-half of a PEM that has a frequently observed defect: the silver-plated inner ends of the lead fingers -- just where the wires from the chip are bonded -- are delaminated (red areas) from the mold compound. The absence of a bond between the mold compound and the lead finger in this area means that thermal changes can cause movement, and that moisture and contaminants can gather here. Either of these events can break wires. A likely cause of this defect is the choice of a mold compound that does not adhere well to silver. In a sense, this is a design problem, but the design and material choice are in the hands of the component manufacturer, and not the assembler of the medical system.
