Finding Singulation-Caused Cracks in MLCCs

By Tom Adams, Consultant, Sonoscan, Inc.

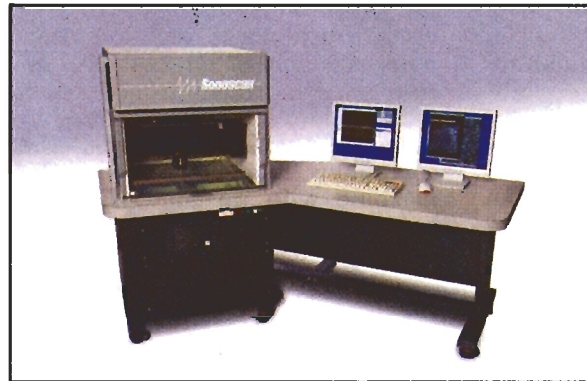
Sonoscan's new D-9500 "Gold Standard" C-SAM acoustic microscope system.
