## How to Detect Laser-Weld Defects in Pacemaker Casings

**Acoustic imaging is a nondestructive technique for detecting voids in titanium pacemaker casings.**

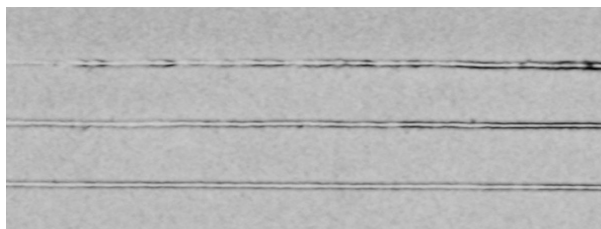
**Figure 1: Surface and near-surface acoustic image of three continuous test welds.**

A reference image whose purpose is to locate interior features, Figure 1 presents the acoustic image of the top surface and near-surface of the stainless-steel plate featuring three continuous test welds. Because the ultrasound in this image was primarily reflected from the interface between the water couplant and the plate, no internal features are visible. The acoustic appearance of the weld surface does not reliably correlate with internal features or defects.

Figure 2 presents a subsurface acoustic image of the same region of the stainless-steel plate as that shown in Figure 1. This image was produced using data from echoes at a depth extending through the weld but not extending to either the top or bottom surface of the material. Most of the image shows a mottled pattern caused by the grain structure of the metal. Indicated by arrows, the bright white features present in two of the three welds are voids. The third weld is not visible when imaged at this depth because it has no voids. By showing the location and size of the voids in the first two welds, this acoustic image could tell engineers that the welding process must be modified.

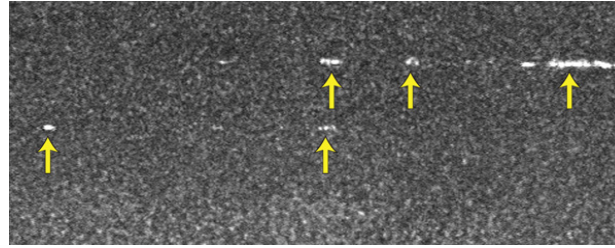
**Figure 2: Subsurface acoustic image of the same three welds as in the first figure. The bright areas marked by arrows are voids in the welds.**

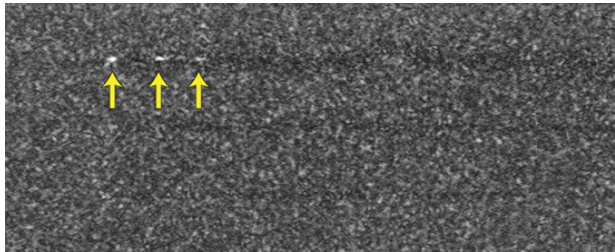
**Figure 3: On a different area of the test sample, weld 1 has three defects. The one at the left is a keyhole defect.**

Figure 3 presents a subsurface acoustic image of three continuous welds at a different area of the sample. Probably because of small differences in gating or other parameters, the three welds are faintly visible in this image as slightly darker regions. It is likely that welding in these regions altered the grain structure of the material, reducing its ability to reflect ultrasound.

While welds 2 and 3 in Figure 3 did not return echoes, indicating that anomalies were not present, weld 1 contained three small defects. The middle and right defects were voids similar to those that formed as a result of excessive heat in the welds in Figure 2. But the defect at the left was a keyhole void—a void that is at least partly open to the surface. Keyhole voids form when the laser begins to perform the welding operation. A near-surface acoustic view of the end of this weld, including the roughly oval-shaped keyhole defects, is shown in Figure 4.

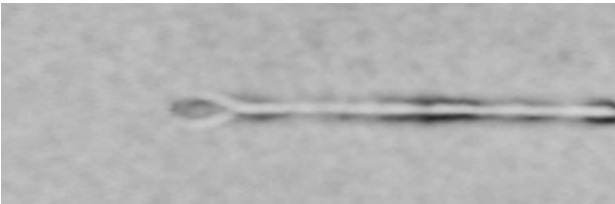
**Figure 4: Near-surface image of the end of weld 1 shows the structure of the keyhole defect.**
