# New Techniques to ID COUNTERFEIT ICs

Acoustic micro imaging can reveal whether the die and lead frame are genuine.

by DR. LAWRENCE W. KESSLER AND THOMAS SHARPE

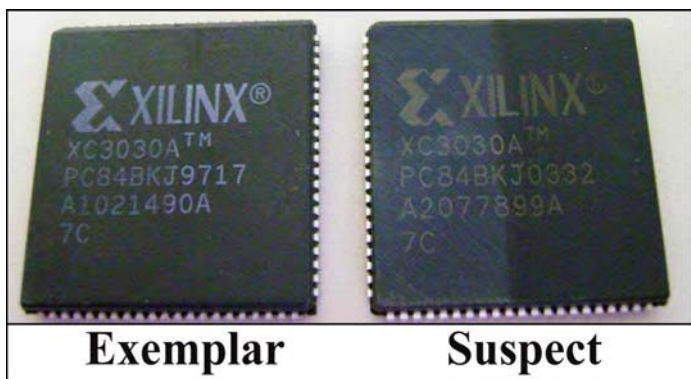
**FIGURE 1.** New technique removes highly engineered blacktop from counterfeit at right without changing surface of genuine component at left.

In January, SMT Corp. further refined that process using a different Dynaloy product called DynaSolve 750. After considerable experimentation on a wide range of counterfeit and authentic parts, a temperature/duration process was identified that completely removed the new blacktop (exposing the sanding marks below) – yet had no effect on the factory-applied topcoats of all authentic components tested. The refined process required the DynaSolve be preheated to 105°C and the suspect component to be half-immersed for 45 min. (FIGURE 1).

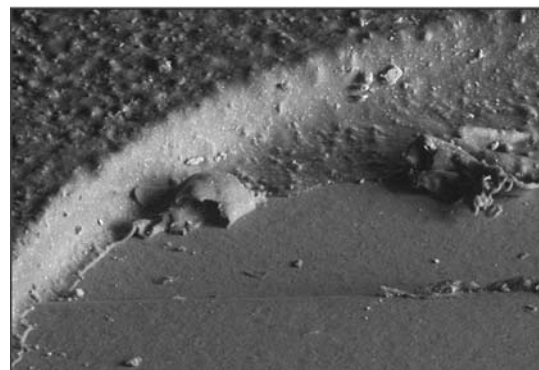
**FIGURE 2.** SEM image shows highly engineered blacktop material within pin-one cavity. (Photo courtesy Tescan USA)

visibly coated the upper portion of the side of the component. In addition, the blacktop material had in some cases been sprayed into the pin-one cavities, with the result that the cavities in close optical view appeared roughly textured rather than perfectly flat and smooth. FIGURE 2 is a SEM image of a portion of one pin-one cavity that has been partly sprayed. Some cavities, however, were completely clean and resembled those found in genuine parts.

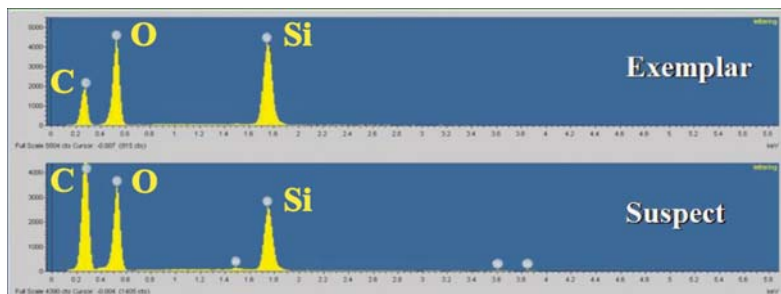
**FIGURE 3.** Spectrum analysis shows similarity of genuine component and highly engineered blacktop material. (Tescan USA)

EDX analysis compared the results of the new blacktop material with analysis of the top surface of known genuine components. The results (FIGURE 3), while not identical, suggest it is possible that the sprayed-on blacktop had its origins in the dust created by sanding genuine components.

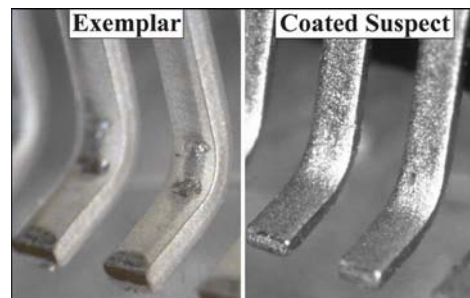
**FIGURE 4.** Surface scaling at bend in genuine leads (left) is concealed by counterfeit plating (right).

Another clue was found in the leads of the components. At left in FIGURE 4 is a light microscope view of two leads from a genuine component. Because these leads were straight when coated, the forming process produced some cracking or scaling of the coating

at the bend. This is an expected feature on genuine components. But counterfeiters apply coatings to leads that are already bent, so cracking and scaling are absent. The coating applied by counterfeiters also rounds off the lead ends and conceals the copper base metal visible in the cut-off lead ends on the genuine parts.

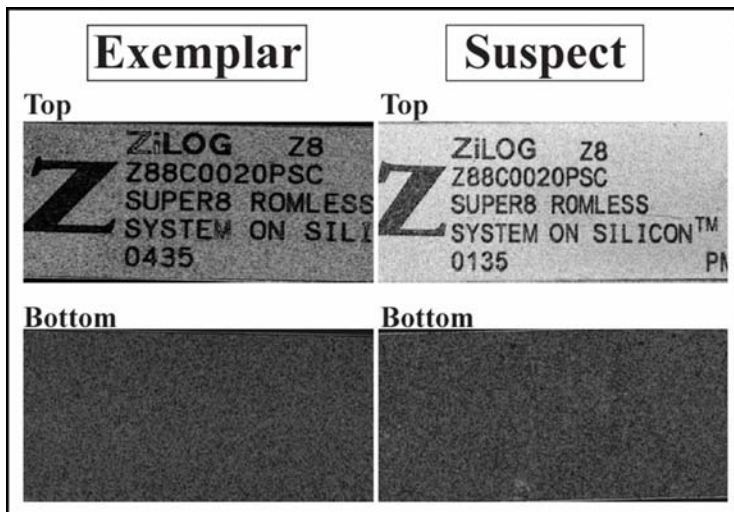
**FIGURE 5.** Acoustic micro imaging of surface of counterfeit component shows differences in material properties between top and bottom.

During acoustic imaging of components, it is customary to scan the top surface of the part by itself for reference. The surface image gives no information about features at depth, but it turns out to have value in identifying counterfeits when the bottom surface, which is ordinarily not of interest, is also imaged. In genuine components, both surfaces appear identical acoustically because they were formed from the same

material during the same injection molding process. But in a recycled fake where the top has been blacktopped, the two sides often look very different. (FIGURE 5).

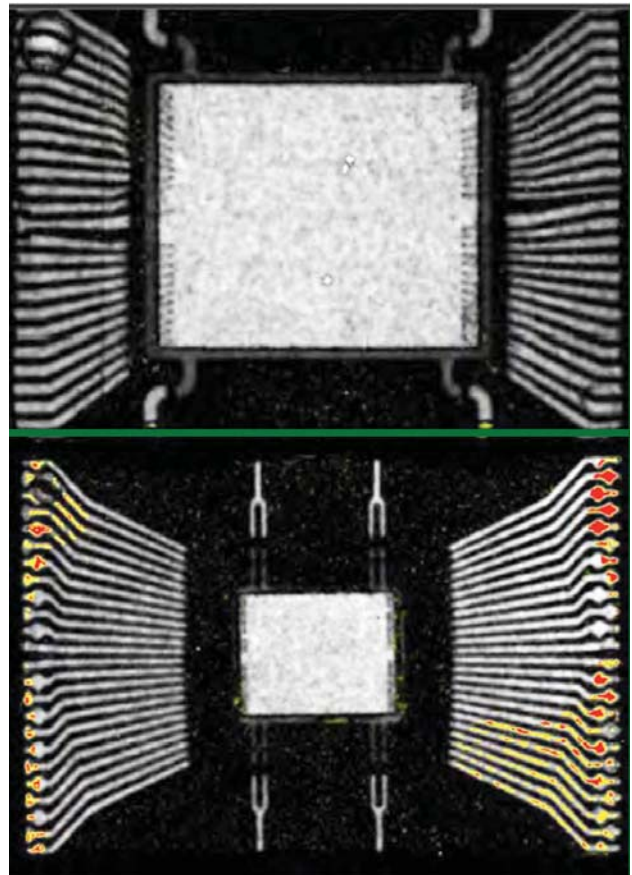
**FIGURE 6.** Close to identical in visual appearance, these two parts held internal surprises when imaged acoustically. Fake component is at bottom.

When an acoustic micro imaging system targets a specific depth within a counterfeit, strange things are sometimes found. FIGURE 6 shows two outwardly identical components having the body dimensions, the same label and the same number of leads. But the acoustic image shows that the component at bottom is either a newer die revision from the manufacturer utilizing a smaller die or is from a different component manufacturer altogether and uses entirely different die and lead frame. It also has small delaminations (red and yellow) on nearly all of the lead fingers.

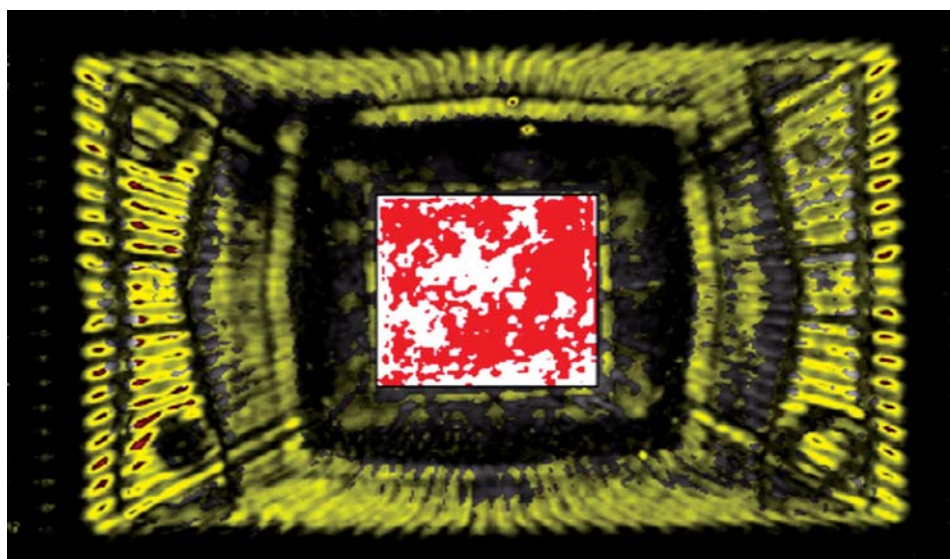
**FIGURE 7.** Red areas seen acoustically are >50% delaminations in die attach in counterfeit component.

Recycled components may show a relatively greater degree of delamination, presumably because of the thermal and mechanical stresses of prior use and of the counterfeiting process itself. **FIGURE 7** shows the acoustic image of a known counterfeit component whose die attach delaminations (red areas) exceed the standard. Digital image analysis showed delaminations covered 57.12% of the die attach area.

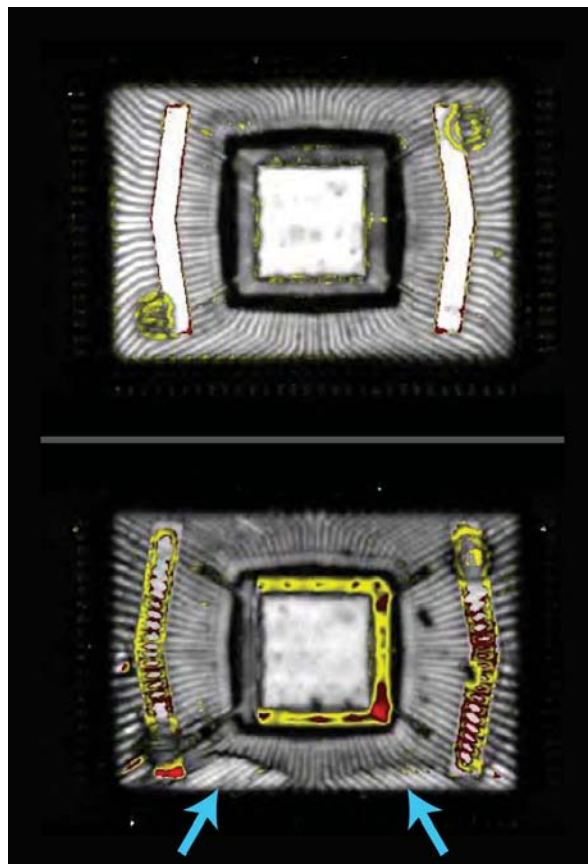
**FIGURE 8.** Component at bottom has novel acoustically imaged anomaly (arrows) seen only in counterfeits.

Collaboration between SMT and Sonoscan has resulted in the identification of internal features not previously seen acoustically in components. **FIGURE 8** is the acoustic image of a pair of components. The genuine part at top shows minimal defects. The recycled counterfeit at bottom shows numerous delaminations (red, yellow) on the die paddle and on the tape. But it also shows a surprising feature: two over-bright regions (arrows) near the bottom edge. Something has happened along this edge to make the interface between the mold compound and the lead fingers appear brighter than elsewhere, and the upper edge of this phenomenon is marked by a dark line. Two possible explanations: Sanding may have altered the top edge of the component, causing the returning ultrasonic echoes to bend; or heat may have re-cured or otherwise altered the mold compound in this region, but without creating a gap (delamination), which would be red or yellow. Strange effects seem to occur when components are subjected to heat, mechanical shock and moisture in uncontrolled environments.
