# Solar+Power MANAGEMENT

# SOLAR PANELS

## Faster acoustic inspection

By maximizing the scan area and developing innovative software, it is possible to significantly increased both the speed and the efficiency of the inspection process. Tom Adams, consultant, at Sonoscan, Inc explains.

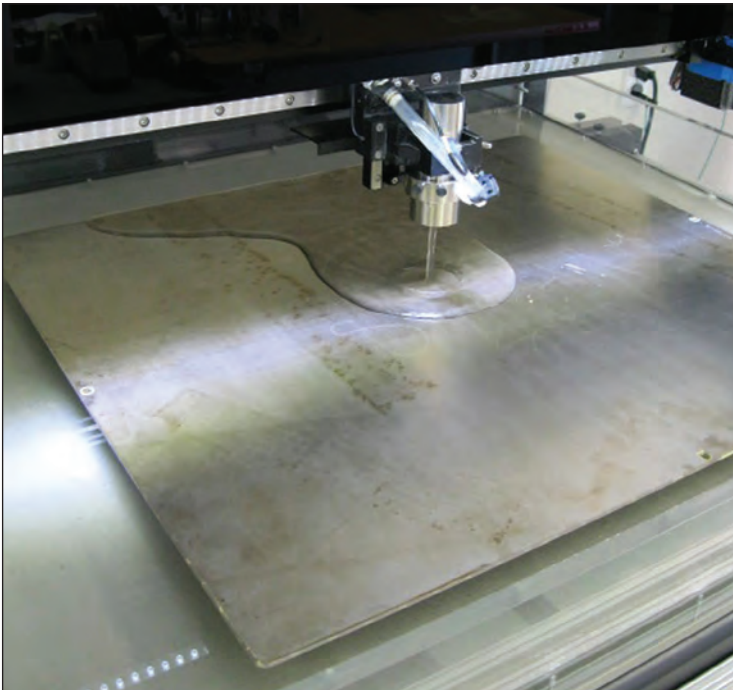
Figure 1: Sonoscan's oversized scan area, here at work on a very large unpopulated PC board, speeds the inspection of solar panels.

Sonoscan also developed a C-SAM AMI tool that has a much larger scan area (0.6096 m x 0.6096 m) than other laboratory, semi-automated or automated AMI tools. It is shown scanning the bottom side of a large pc board (solar panels being proprietary) in Figure 1. Some solar panels can be imaged in their entirety in one scan, without repositioning the panel. Even panels measuring up to 1m x 3m require relatively few scans. Because there are many fewer interruptions of the scanning process to reposition the solar panel, inspection is much faster. To further speed the inspection process, Sonoscan has developed software that can accommodate scanning to the geometry of the panel. The layered structure

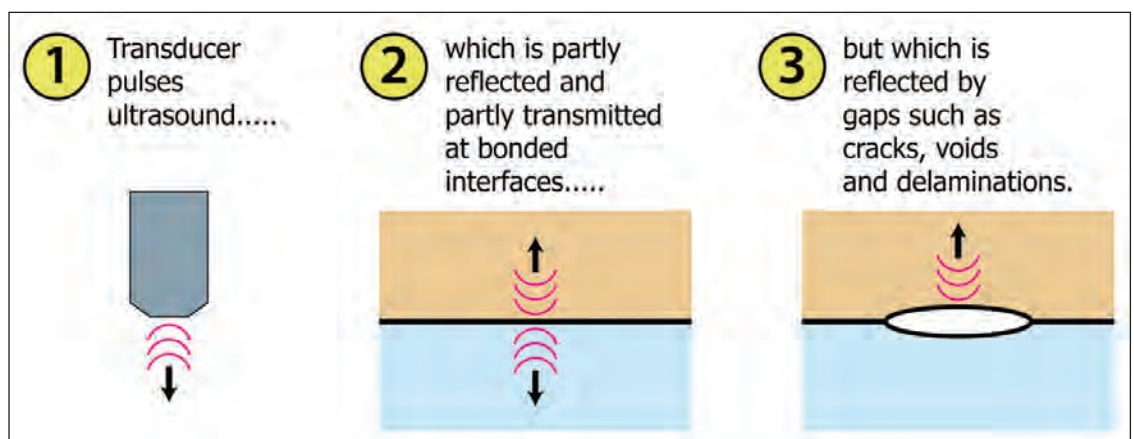
Figure 2: Well bonded interfaces both reflect and transmit an ultrasonic pulse, while a gap - even one as thin as 100Å - reflects essentially all of the ultrasound.

Well bonded material interfaces in the bus bar attachment reflect a portion of the ultrasound; another portion crosses the interface and travels deeper into the sample. A well bonded bus bar will therefore send back moderate-amplitude echoes that will appear gray in a monochromatic acoustic image. But any material gap, even if it is as thin as  $100\text{\AA}$ , will send back a maximum-amplitude echo that will be displayed as bright white in the acoustic image (Figure 2). The near-total reflection of the pulsed ultrasound is caused by the interface between a solid material and the air or another gas in the gap. Bright white features in acoustic image of the bus bars are non-bonds, voids, delaminations or other types of gaps. Their location and size are evaluated to determine how great a threat they pose to long-term performance.

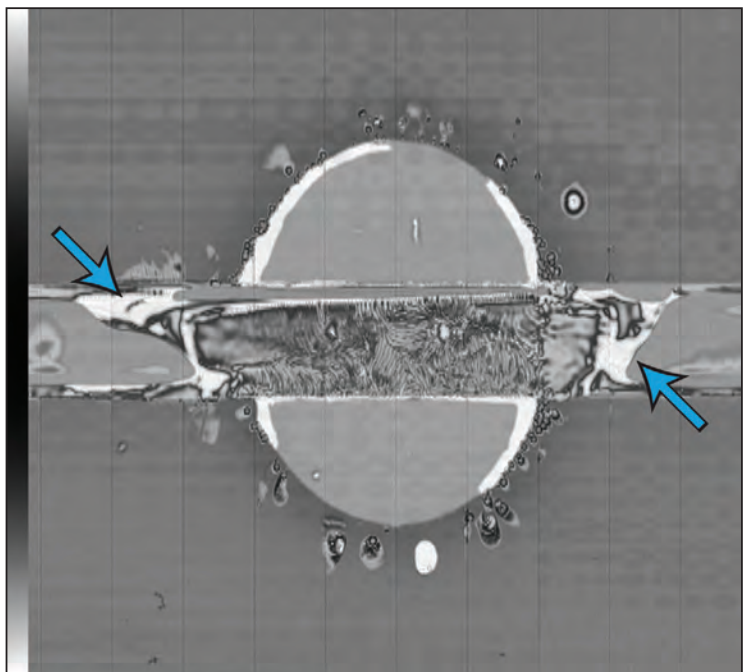
Figure 3: White areas in the acoustic image of a junction box are delaminated. Evenly gray areas are bonded.

Figure 3 is the acoustic image of one junction box, where the bus bar is soldered to the solar cell. The depth imaged was the glass-to-silicon interface. Imaging revealed two areas of concern:

- The bond between the bus bar and the silicon. Only the right and left regions of the bus bar display the medium gray tone that is indicative of successful bonding. There are significant regions (blue arrows) whose white color indicates that they are delaminated or non-bonded. In the center of the bus bar weld only small regions are well bonded (the medium gray seen at the left and right extremities) and there are numerous small delaminations. These anomalies may be the result of thermal interaction between the bus bar and the bond pad during assembly.

- The bond pad. Most of the area of the oval bond pad seems to be well bonded (evenly gray), but the outer edges of the bond pad are white - delaminated or non-bonded. Although these regions are relatively small, they are likely to expand in area until the bond itself is compromised. The bond pad is also surrounded by small more or less circular features that are likely to be voids.

Figure 3 is representative of the sorts of defects that need to be found during acoustic inspection of solar panels. By maximizing the scan area and developing innovative software, Sonoscan has significantly increased both the speed and the efficiency of the inspection process.
